TRANSCANADA TURBINES

Corporate Presentation

**INDUSTRIAL RB211
USER GROUP**

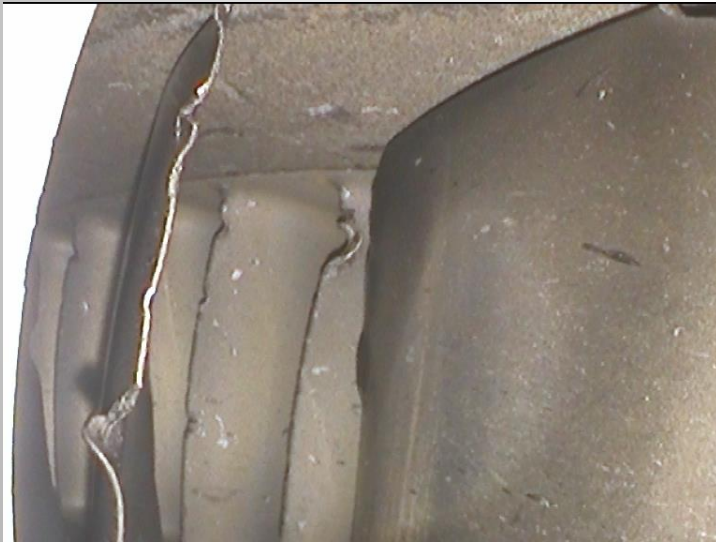
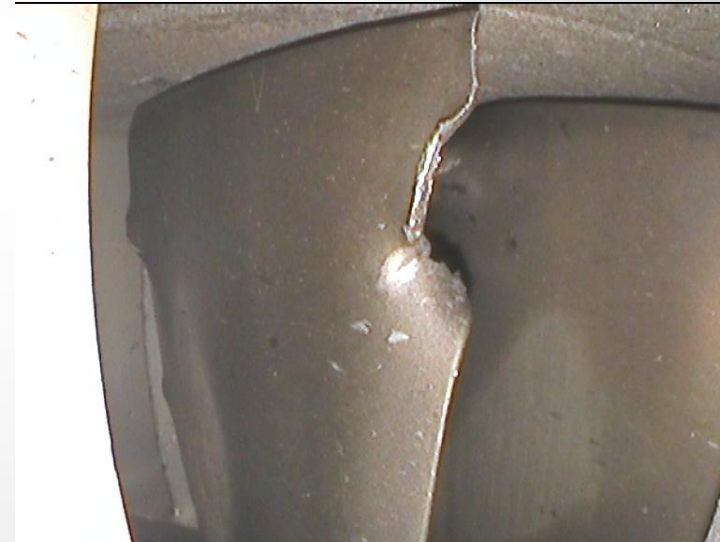
- Engine trip event followed by multiple, unsuccessful start attempts.
- Exhaustive troubleshooting prompted a borescope inspection, where severe damage was observed to the HPC gas path.

- Engine removed from berth and inducted at TCT Depot for investigation and repair.

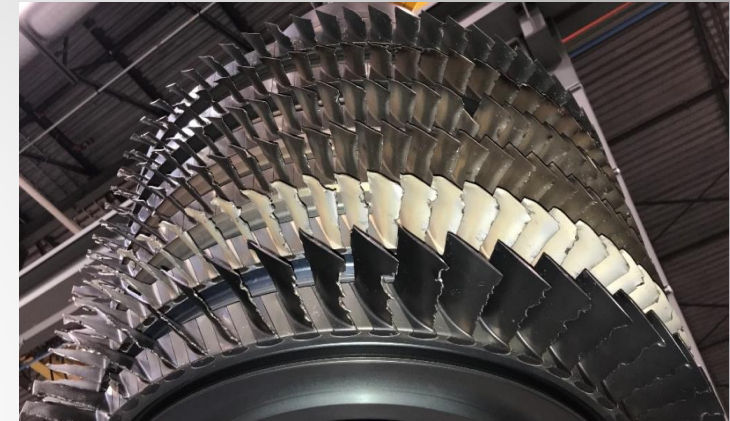
HPC Stage 1 -6 Blade Condition

- Extensive damage to HPC Blades and Vanes with nicks, dents and tears present in all stages
- HPC Stage 1 Blades: QTY.2 blade airfoils liberated
- HP OGV: ledge edge nicks and dents
- Material splatter and minor impact damages observed on the HPT Blades and HPNGV's.

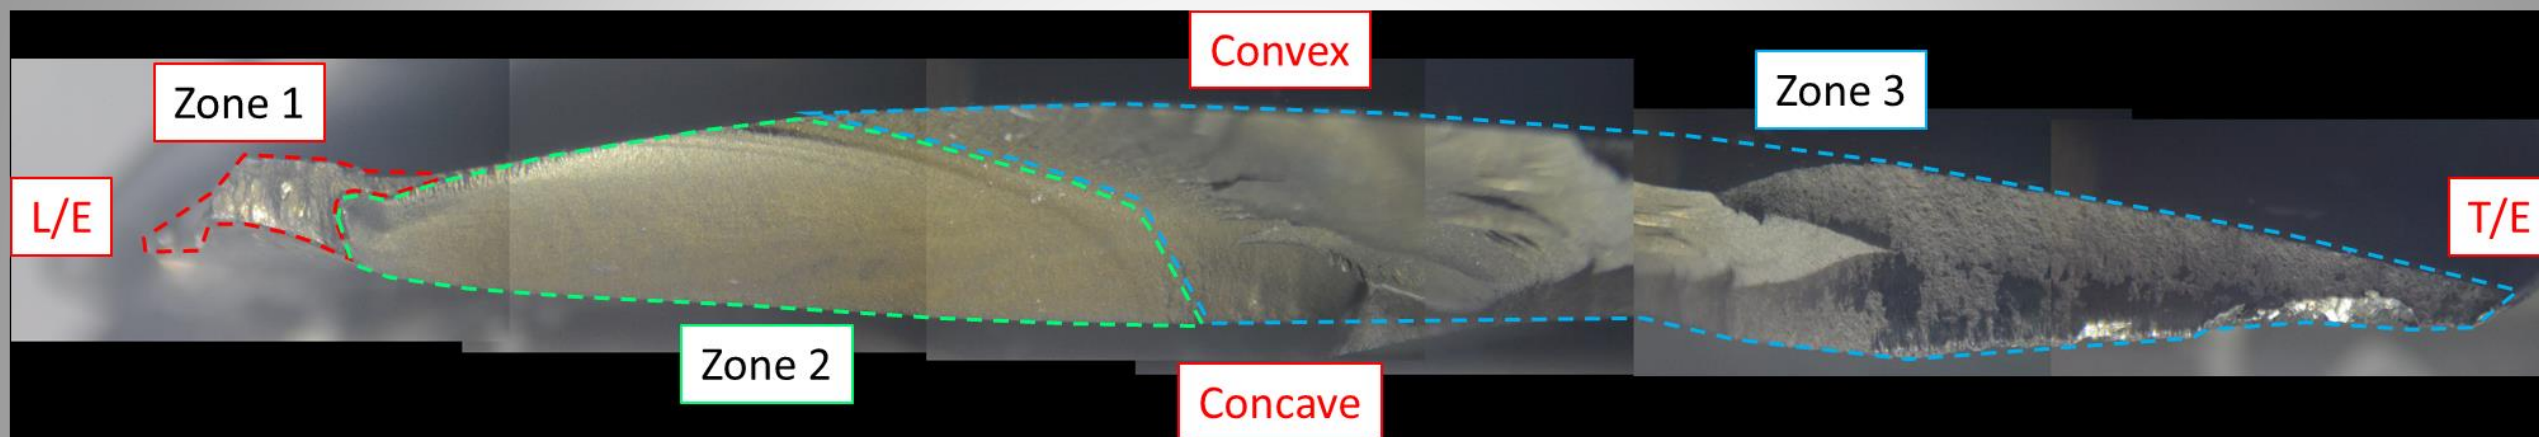
Preliminary Findings - HPC Stage 1 Blade #59

- Zone 1: Leading edge deformation moving from the concave surface to the convex. Leading edge tear condition has visible oxidation present
- Zone 2: Thumbnail shaped, flat and visibly oxidized fracture surface. Characteristics are consistent with stable fatigue crack growth.
- Zone 3: Fracture surface consistent with overload condition.

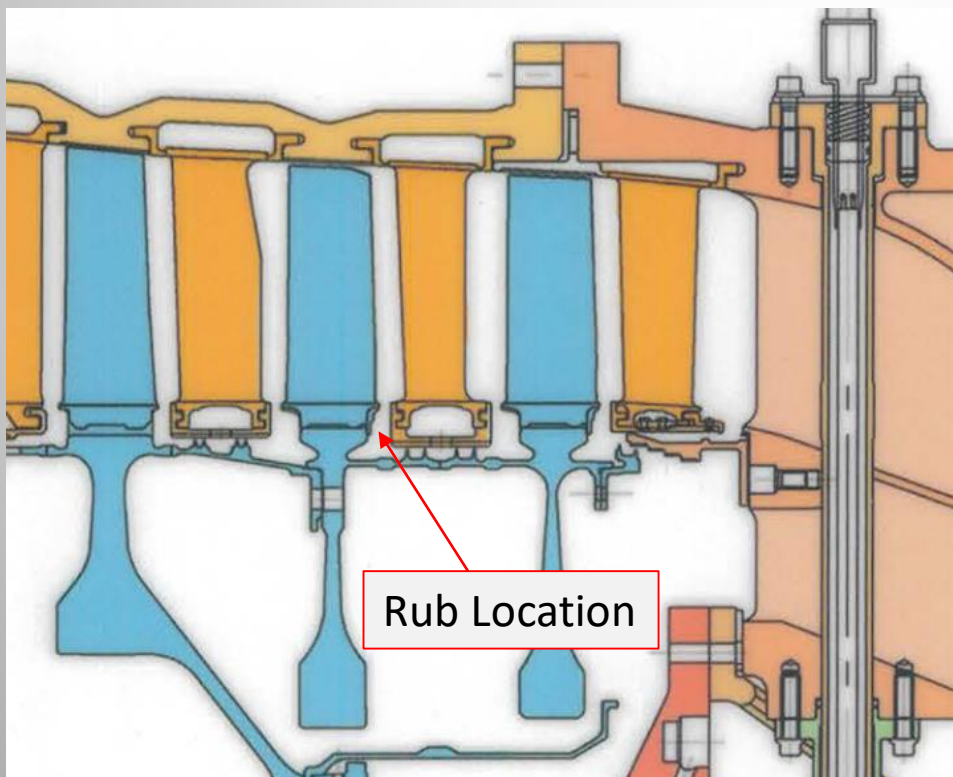
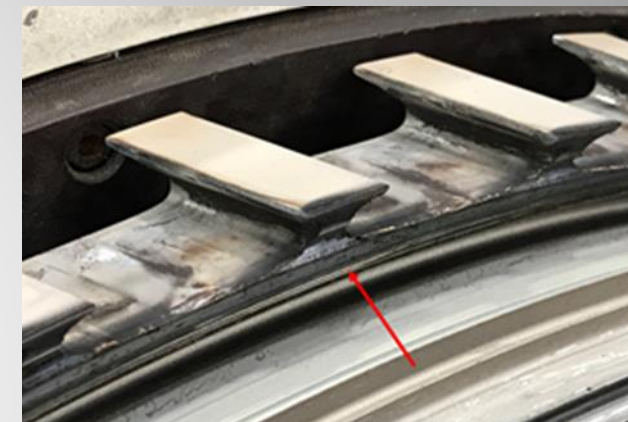
Heavy Rub on aft face of IPC stage 6 Disc Rim

- IPC Stage 6 disc and blades were found to have heavy rub condition as evidence of bluing and wear marks.

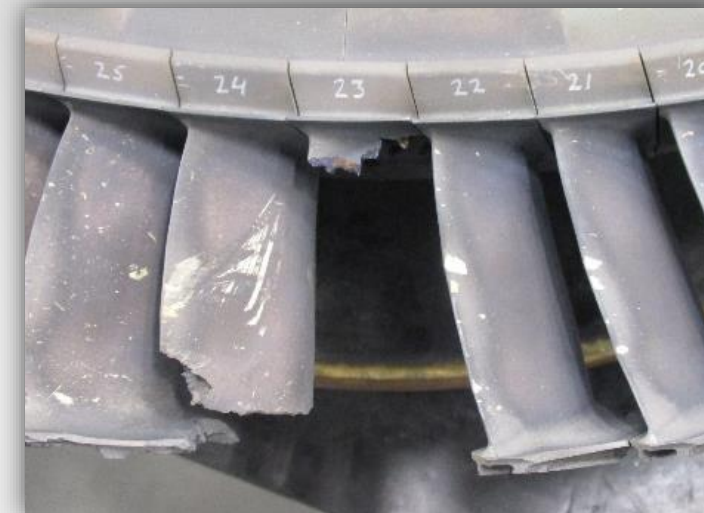
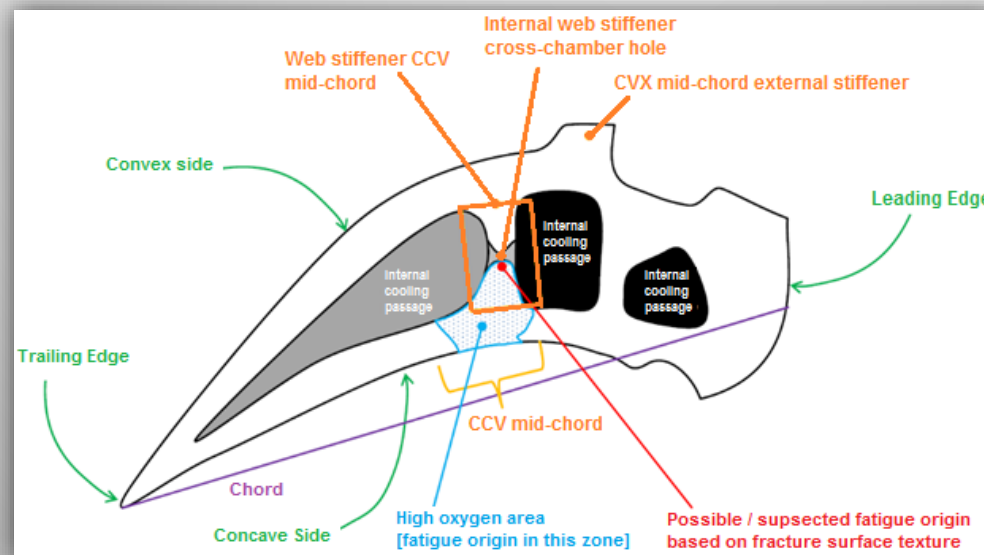
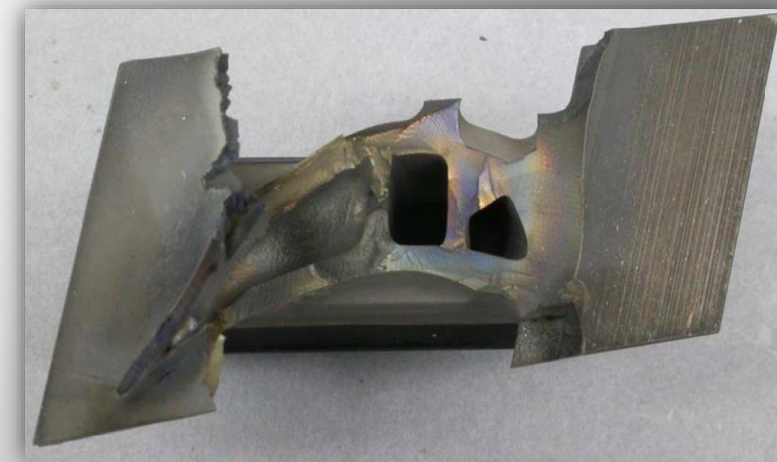
Re-Cap - Summary of Event Analysis

- Single HPT blade failure after 11,280hrs.
- Investigation conducted by TCT. Subsequent contributions from Liburdi and Siemens.
- Initiation site at internal web in blade shank; HCF propagation.
- The origin area did not exhibit any apparent 'defects' or 'deficiencies'.
- No significant environmental contaminants identified.
- TCT concluded that it was unlikely that environmental mechanisms caused or contributed to the failure (i.e. Sulphidation, hot corrosion).

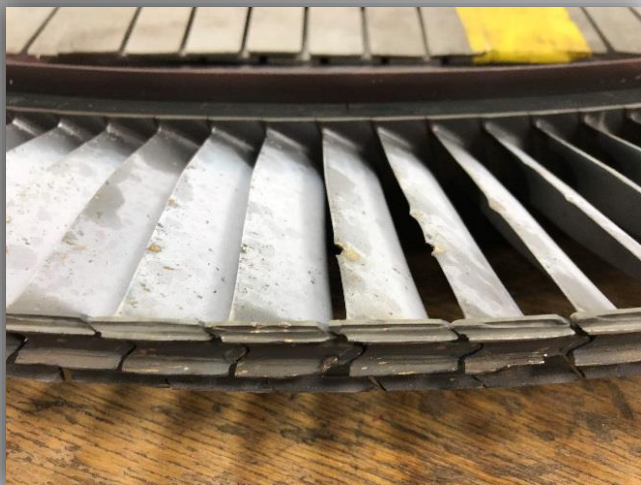
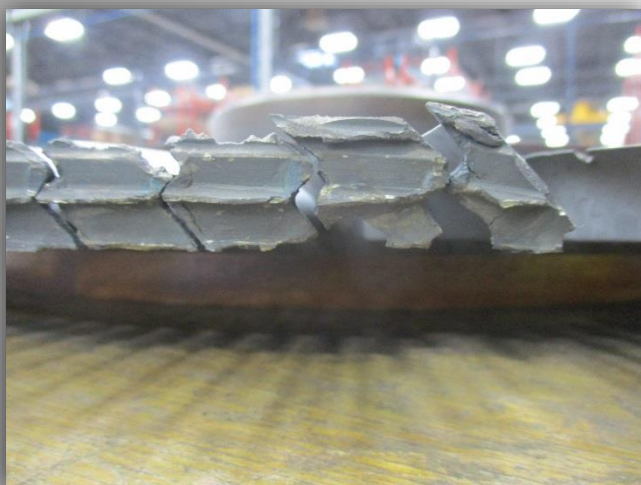
IP Turbine Condition As Found

- Prior to 2019, TCT has not witnessed an IP Turbine Blade failure on –GT or –GT-DLE
- April 2019, TCT was contracted by a first-time client to perform a Failure Analysis on an IP Turbine Blade Failure they recently experienced in the field (RB211-GT), 25k TSO, 75k TSN.
- Engine strip is currently progressing – photos of preliminary findings on the following slides

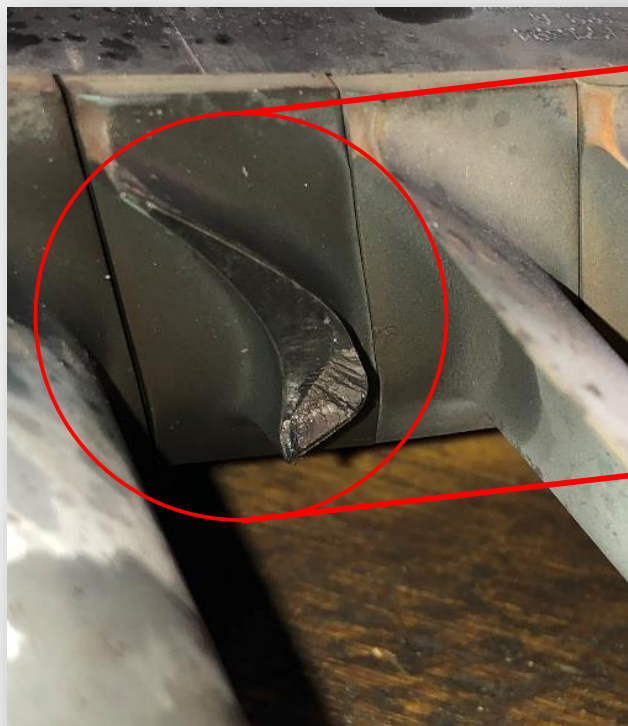
Incident IP Turbine Blade

1. Suspected Trailing Edge Fatigue
2. Suspected Leading Edge Overload

- TCT's investigation completed in the weeks after the 2019 ETN RB211 Conference
- Summary of Blade Analysis Findings:
 - IPT Blade fractured approx. 0.2" above the root platform
 - Crack origin at the Trailing Edge of the suction side
 - Metallurgical evaluation concluded the failure was crack propagation in high cycle fatigue (HCF)
 - There was no evidence of inherent material defect at the fracture origin
 - There was no evidence of a distinct FOD or DOD event as an initiator to cracking/fatigue
 - There was no evidence of environmental contamination on the incident blade

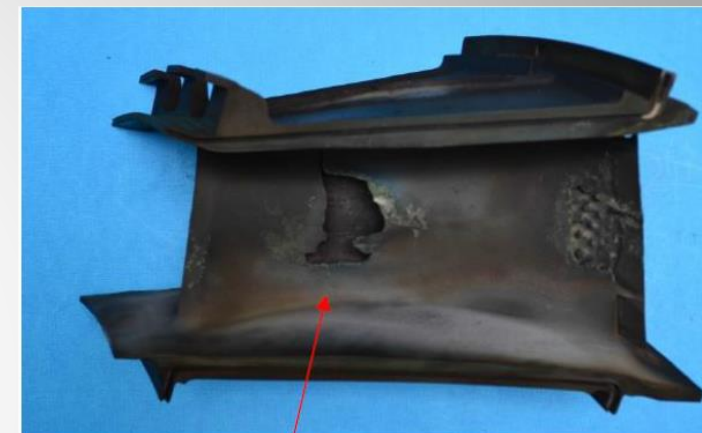
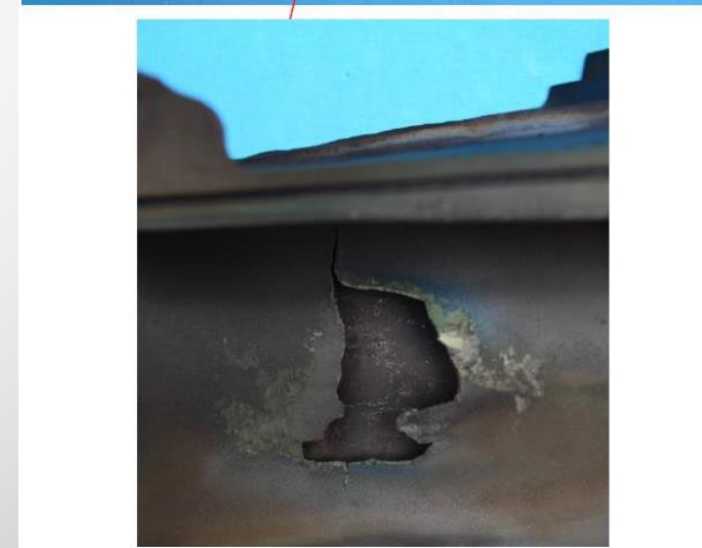
- Other Engine Component Findings:
 - Qty 1 IP NGV had degraded to the point of complete breach through its airfoil skin
 - IP Turbine Disc Firtrees exhibited galling over the entirety of the disc.
 - Condition subsequently rejected by Siemens Engineering via TLRF

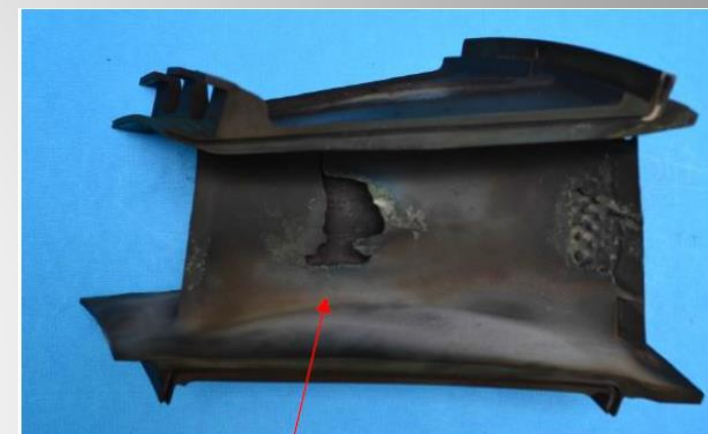
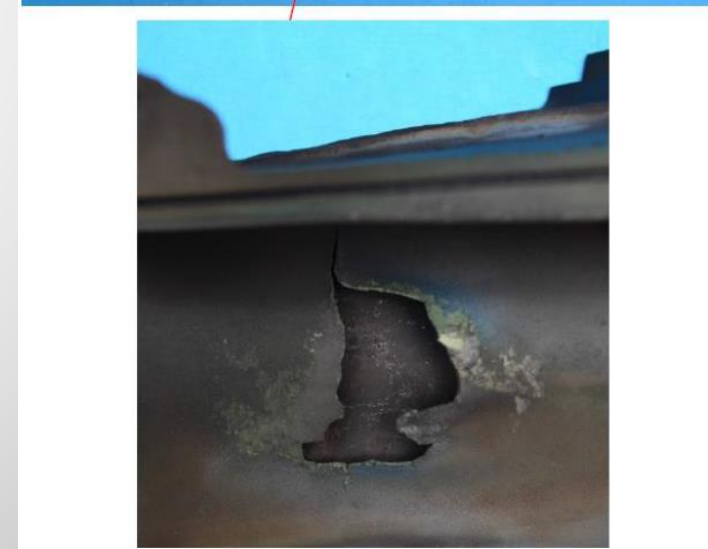
- The airfoil breach was significant enough to have plausibly caused a once-per-revolution impulse to the IP Turbine Blades due to airflow disturbance
- Further analysis was suggested to the customer to explore this possibility further (modal analysis of the GT IP Turbine Blade)

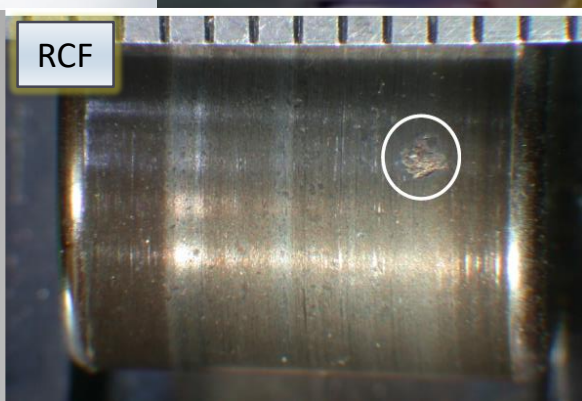
RCF

1. Rolling element/raceway rolling contact fatigue (RCF).
2. Progression to macro spalling (**flakes/debris on MCD's**).
3. Cage pocket wear & fatigue damage to cage.
4. Cage/riev failure leading to seizure, destruction of bearing, loss of rotor location.

Metal to metal contact resulted in repetitive sliding & scuffing contact between the raceways and rolling elements.

- Monitor oil quality (particulates, acidity water content etc).
- Check MCD's at regular intervals.
- Monitor vibration and oil system parameters for trends and step changes.
- Ensure package air filtration is effective.
- Ensure package oil system is properly flushed before engine is returned to service (if previous bearing failure experienced).

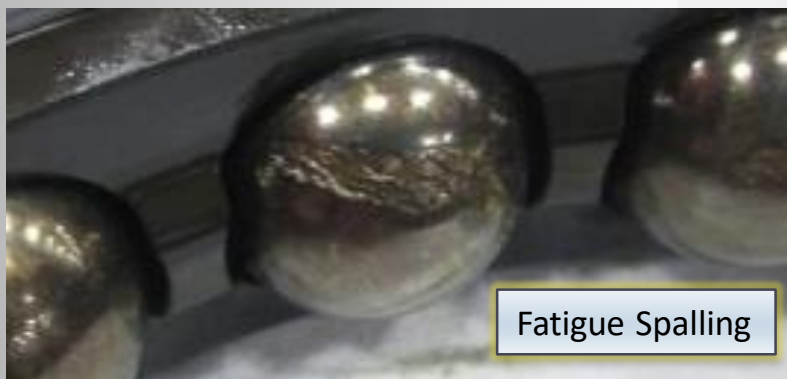
Fatigue Spalling

1. **Sliding Contact Fatigue** (SCF) initiated surface cracking.
2. Cyclic stresses propagated the cracks resulting in **progressive fatigue spallation** and release of bearing chips/flakes.
3. Released debris caused **hard particle indentations**, resulting in elevated contact stresses and **acceleration of the fatigue spallation**.
4. Areas of fatigue spallation caused balls to hammer the cage pockets; imparting fatigue stresses to the cage with **eventual initiation of a fatigue crack in the cage**.

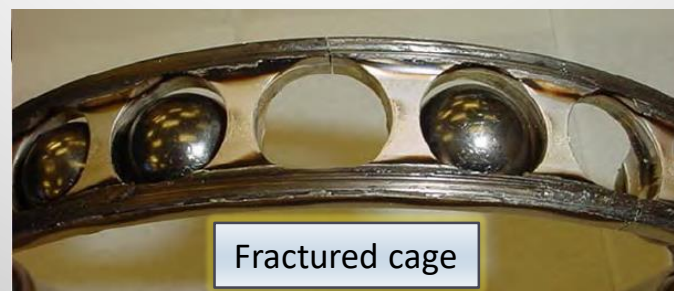
Fractured cage

The cage fatigue crack propagated to a through-crack, allowing cage to splay outwards and rub heavily against the outer race. Rapid generation of metallic debris resulted and consequent blockage of the L3 scavenge screen that resulted in the alarm and engine trip event.
