ETN SGT-A35 User Group Day 2 Technical Session

Siemens 8th October 2020

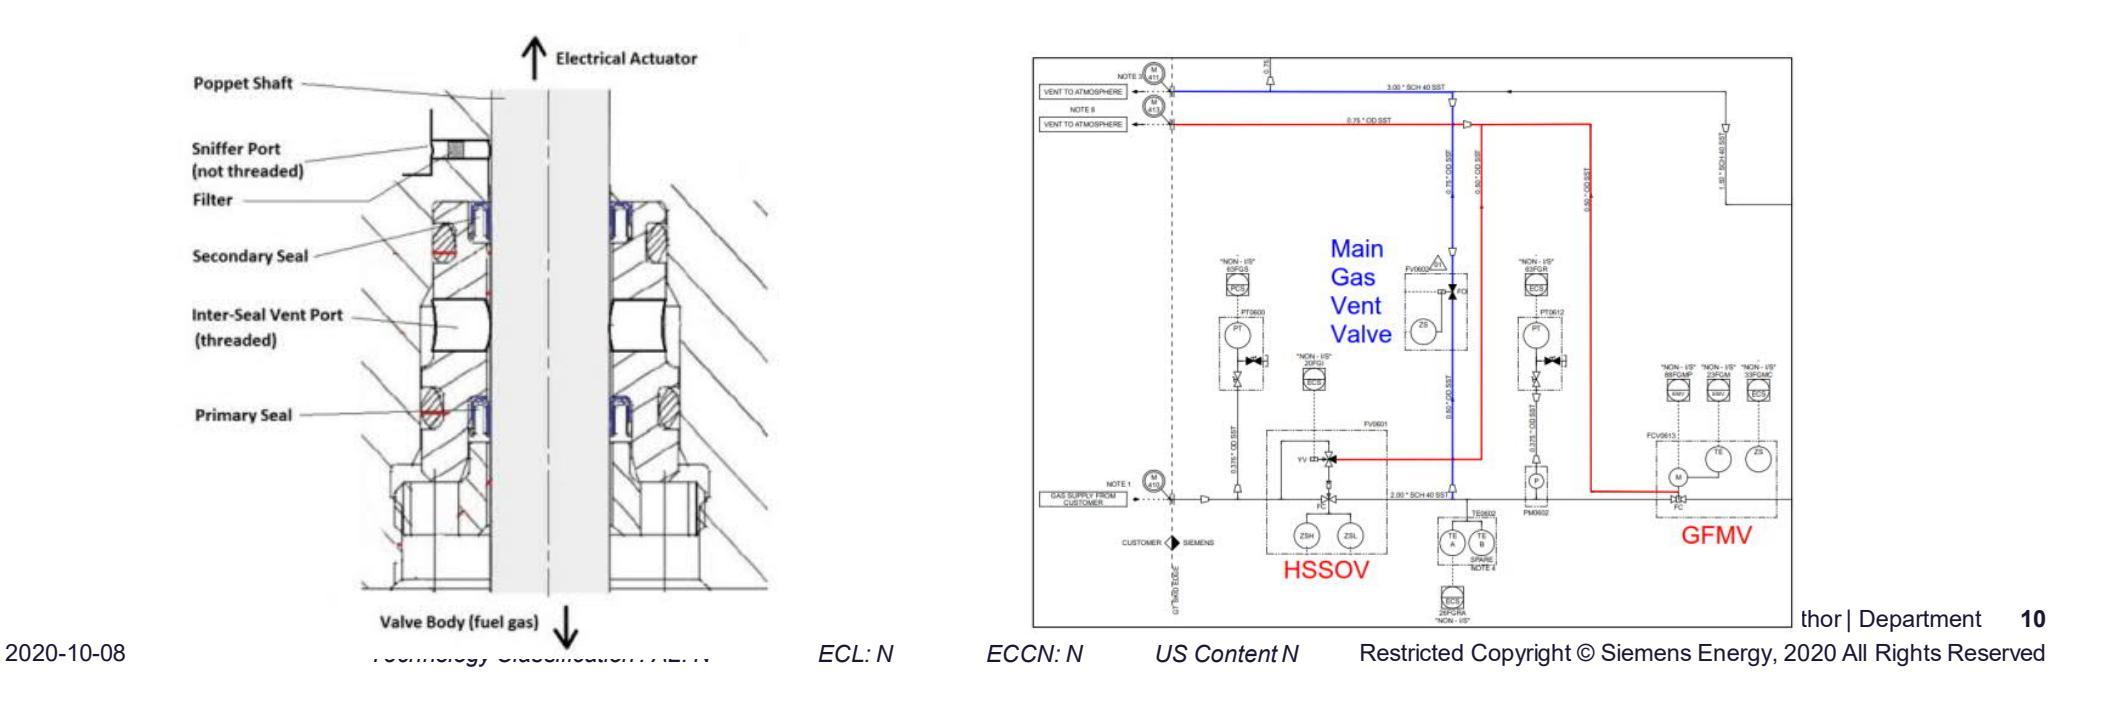
Feedback on the FMV design released in March 2019

- See Siemens Product Advisory Bulletin, PAB01-0001-02, original release, Nov 2016 with updates in 2018 & 2019
- □ Meggitt FMV experiencing stem seal failures.
 - □ Prior to mid-2007: Inter-seal vent port plugged
 - □ 2007 to 2014: Inter-seal vented to main gas vent line
 - □ 2016 to present: Inter-seal vented to separate vent connection as per PAB, as per below.

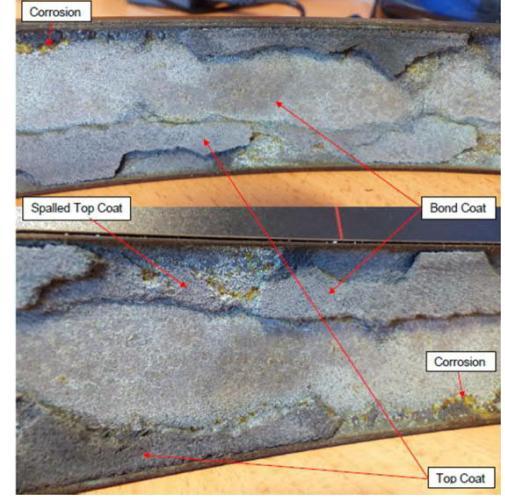
¹¹⁶ Potential risk associated to abradable Metco coating in the HPC coming out

- □ No HPC compressor abradable loss noted in G-rated engines.
- □ Some loss of HPC stage 1 seen in GT engines. Typically occurs in offshore high ambient conditions indicating corrosion is contributory factor. This is confirmed by lab examination.
- □ Abradable lining is brittle and disintegrates on impact with the rotor blades.
- Normally lining loss results in minor tip bending and is usually only noticed during routine borescope or overhaul and does not result in any significant operational problems.

- □ However one engine was removed due to surge and blade damage. HPC1 lining found to be heavily corroded
- □ Ensure engines are fully dried after compressor washing to reduce corrosion.
- □ HEPA filters are recommended to reduce induction of corrosive elements which also reduces requirement for washing.
- □ Siemens can provide E10-E12 grade filters ref PIB01-0008.
- □ Intermediate impact damage can be repaired in the berth by boroblending ref PAB01-0032.

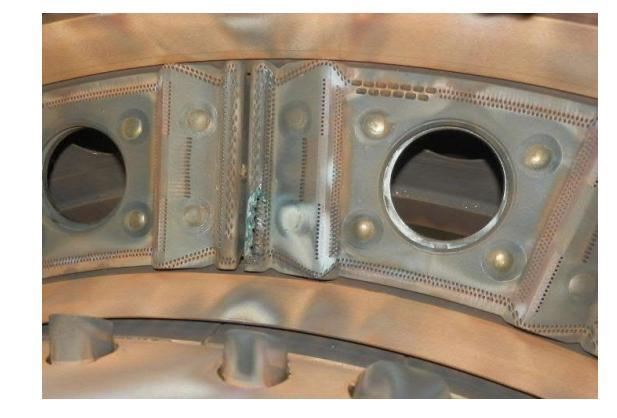
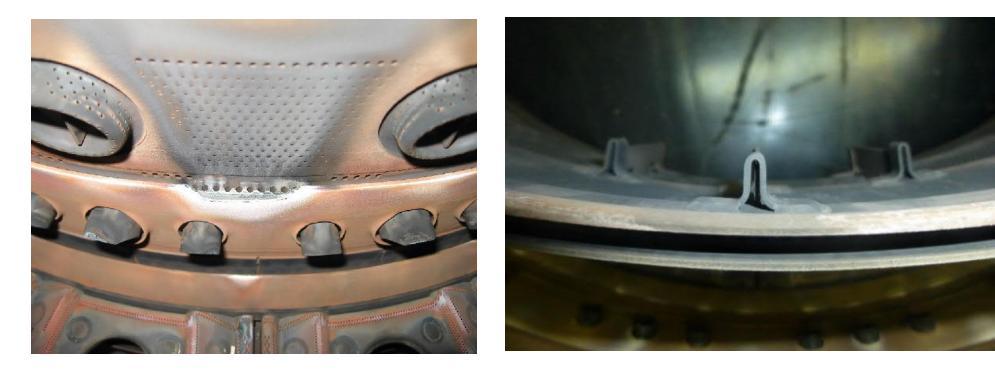
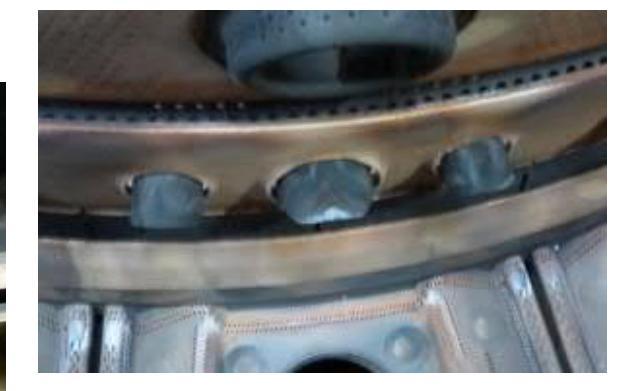
¹⁰⁹ **Mitigate/reduce the effects of hot corrosion**

- □ In normal operation with good fuel the SGT A35 Duel Fuel combustion liner does not suffer from sulphidation.
- □ Over 300 dual fuel engines in operation. ~12m Hours
- □ The only areas which normally exhibit any deterioration are:-
 - Oxidation of the heatshield corners
 - Erosion of the smoke chutes
 - Thinning of the splitters
 - Oxidation of the inner 1st cooling ring (GT only)
- □ These do not limit the life of the liner which routinely achieves 25K+ hours.
- □ These features are easily repaired as part of the normal overhaul workscope.

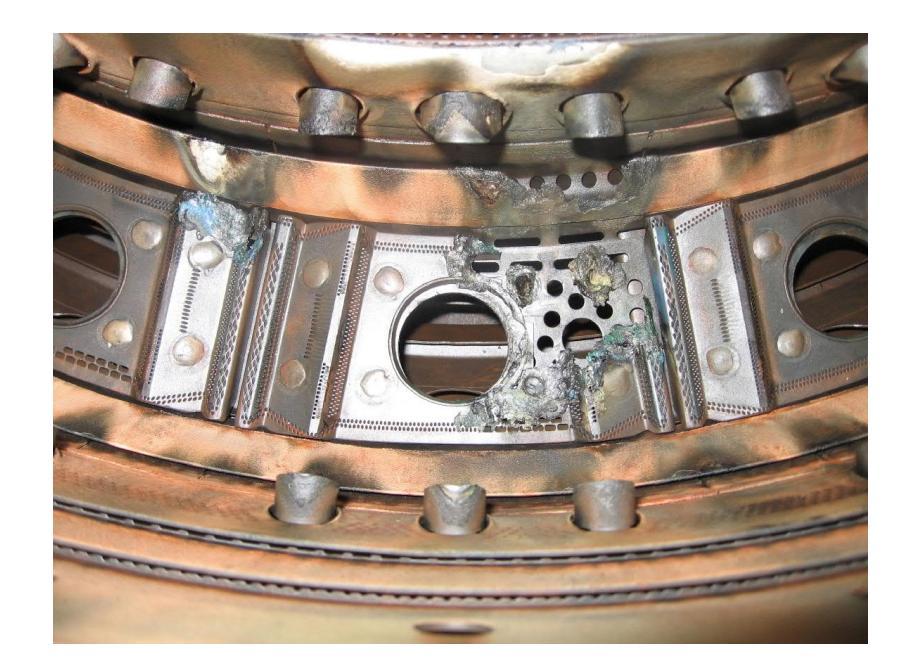
¹⁰⁹ **Mitigate/reduce the effects of hot corrosion**

- There are only 2 or 3 operators who routinely suffer from Sulphidation of the DF FCL
- **Operation with high Sulphur gas fuel in marine environment**
 - <2.5% H2S vs 0.0005% H2S+SO2 limit in PAB01-0020</p>
- Extended operation with high sulphur Diesel fuel in marine environment
 - <3% H2S vs <0.005% Sulphur limit in PAB01-0020</p>
- Determine Both are in marine / coastal environments.
- □ Operation with fuel containing Sulphur above the limits in PAB01-0020 is expected to result in combustion and turbine corrosion / sulphidation.
- Therefore reductions in the recommended overhaul lives are given for these environments.

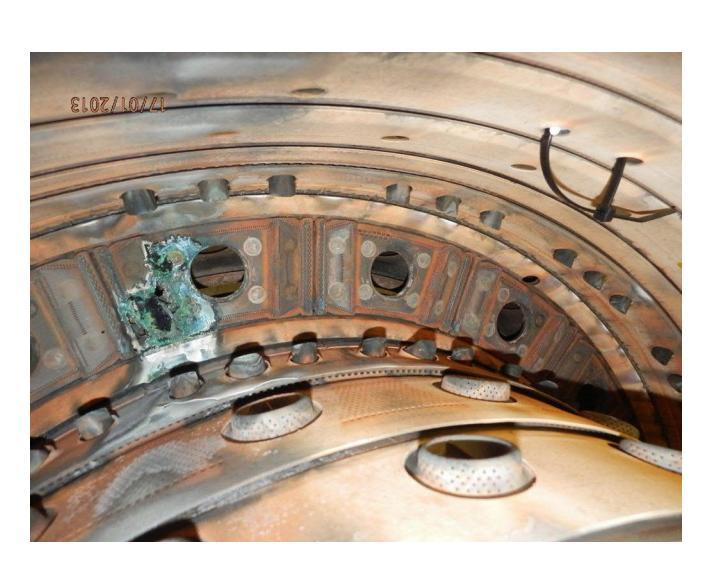
¹⁰⁹ **Mitigate/reduce the effects of hot corrosion**

- □ Hot corrosion is normally caused by a combination of airborne salts and fuel borne sulphur.
- □ Low-moderate levels of sulphur will increase overhaul costs due to additional damage to blades, NGV's and seal segments but does not limit overhaul lives

- □ High levels of sulphur in gas fuel (>1.5%-2%) can significantly reduce engine life primarily as a result of hot corrosion of the combustion liner heatshields.

- Sermaloy J coating can be added to HP and IP turbine seal segments to provide additional protection.
- □ HEPA filters can significantly reduce the airborne salt content ref PAB01-0008.

- Mod 1578 introduces a combustion liner heatshield with Sermaloy
 1515 on the front and rear surfaces and increased cooling through the metering panel.

- □ For the operator with high sulphur gas this, in conjunction with improved intake filtration, in has increased the life of the heatshields from <4K hours to >8K.

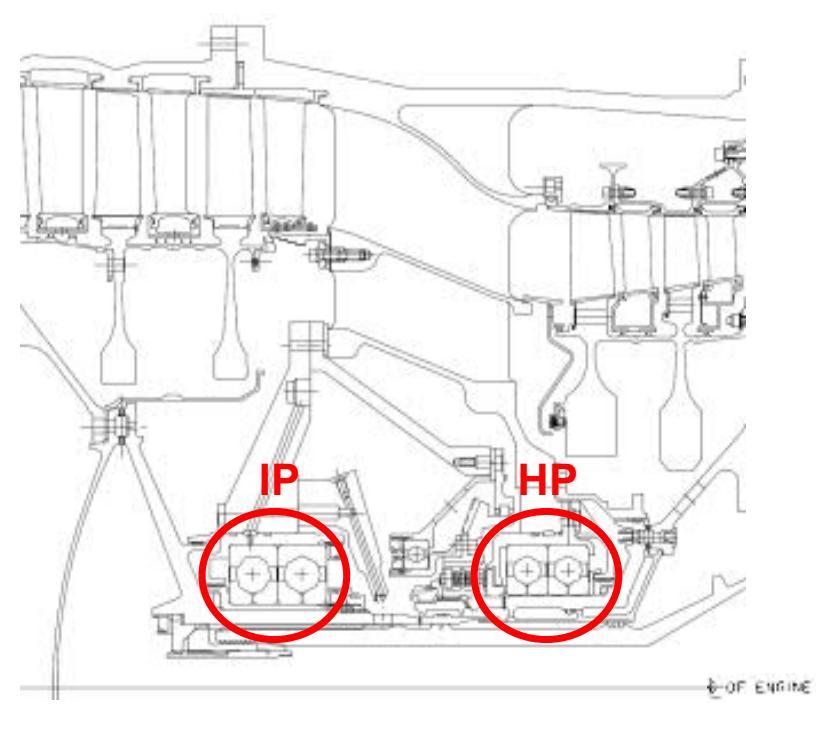
HP Thrust Bearing Reliability & Material Update

The current standard of HP thrust bearing was released in 2001 by Mod1368. This introduced revised material inner and outer races with

improved fatigue strength.

- Mod1368 was introduced primarily to enable a satisfactory life in GT engines which have higher bearing thrust loads. The improved fatigue strength will also make the bearing less sensitive to other failure causes.
- □ Since 2006 the previous standard of bearing is upgraded to mod1368 at overhaul. Therefore since ~2012 most of the fleet will have Mod1368
- To date there have been 9 recorded failures of Mod1368 bearings the last of which was in 2018.
- Confirming the cause of bearing failure is difficult but causes are normally one of the following:- assembly issues, oil contamination, corrosion, shipping damage.
- Assembly improvements were introduced in 2012 by mod1624. This introduced hydraulic tooling to ensure the bearing races are clamped together. This is critical to ensure even load sharing.

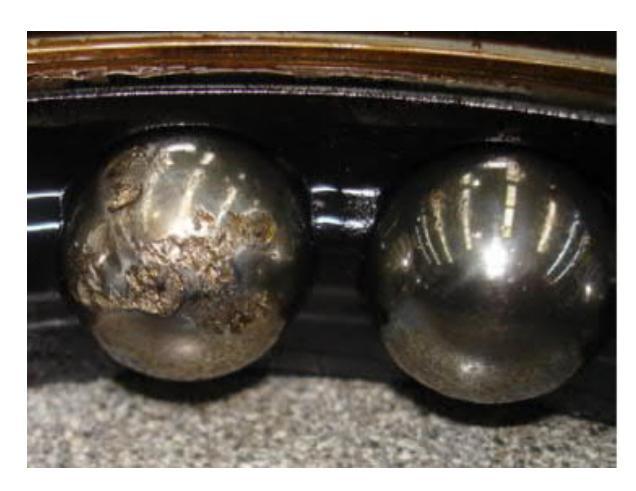
23.1, 23.2, 23.3, 125 HP Thrust Bearing Reliability & Material Update

- Debris on MCD's / QDM's
- Debris on scavenge baskets and supply filters.
- □ Increased filter Dp and potentially low centre bearing Dp.
- □ In a small number of instances HP thrust bearing failure may result in HP speed probe reliability issues on G-rated engines. Broadband casing vibration is generally not effected.
- □ By monitoring vibration and debris engines can often continue to run with a failing bearing while a replacement engine is made available.

- □ To date there have been 9 recorded failures of Mod1368 bearings. The majority of the failures have been at less than 25K hours.
- □ Weibull analysis indicates the failure rate is falling, this may be as a result of improvements made to the build process in 2012. Weibull also indicates the failures are more wear-in than wear-out.
- □ Siemens recommends thrust bearings are overhauled every 50K and not disturbed at 25K.
- □ Siemens has reviewed the availability of different materials which may improve the tolerance to damage, contaminated oil etc. However no superior materials were identified.

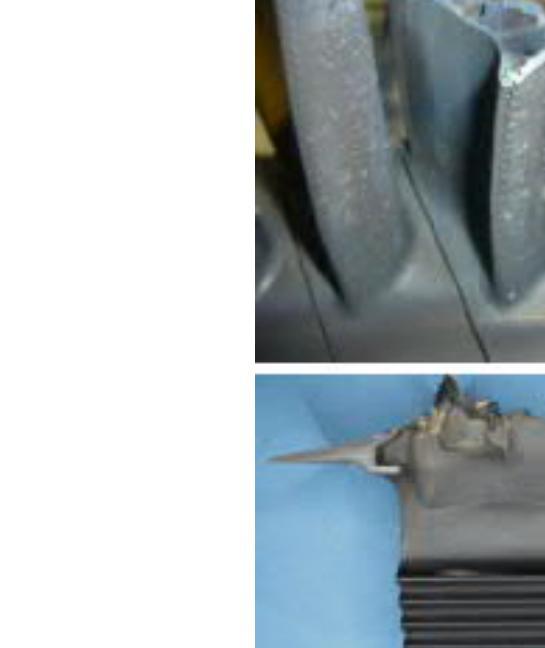
¹²³ HPT blade failure event (2018), and risk for the fleet, (slide#1)

□ There have been 8 HPT blade failures on the A35 GT variant all have been on engines with DLE combustors.

□ Two types of failure mode have been seen:

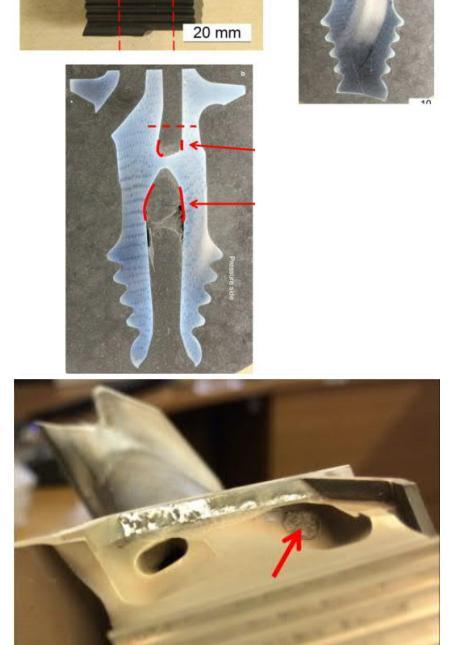
Platform Failures

- Analysis of two failures has been carried out.
- □ Of the failures examined no metallurgical or dimensional defects found
- □ Low temperature sulphidation has been found in the failure region.
- □ Analysis of deposits found in the platform containing sulphur, sodium and potassium were also found

Operators are advised to ensure airborne contamination is minimised which can be achieved by the use of HEPA filters ref PAB01-0008.

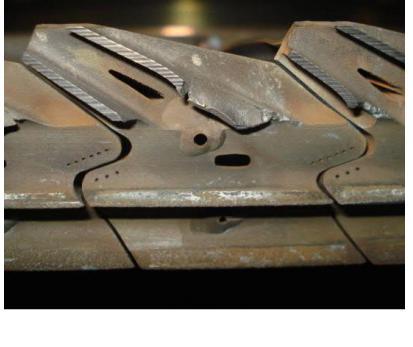
¹²³ HPT blade failure event (2018), and risk for the fleet (slide#3)

- □ Failure is due to High Cycle fatigue initiates at the leading edge. No metallurgical or dimensional defects found.
- Cyclic operation is contributory factor as it causes wear of the shroud interlocks. This allows the blade to vibrate in cantilever modes.
- □ Blockage of fuel injectors as a result of fuel quality was also a factor in one failure.
- □ The vibration mode likely to cause mid-height aerofoil failures is primarily generated by wakes from the NGVs
- □ To minimise risk, Siemens recommends DLE overhaul life is limited to ~25K to maintain interlock condition.
- □ Siemens has initiated a programme to redesign the HPNGV aerofoils to reduce the aerofoil wake strength reducing the vibration forcing on the blade.
- □ The new HPNGV's will be available for retrofit onto the existing DLE combustor as well as with the new <15ppm DLE combustor design.

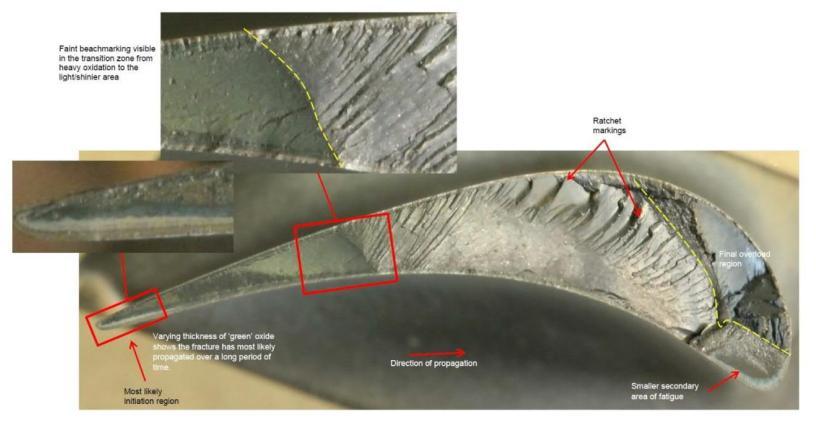
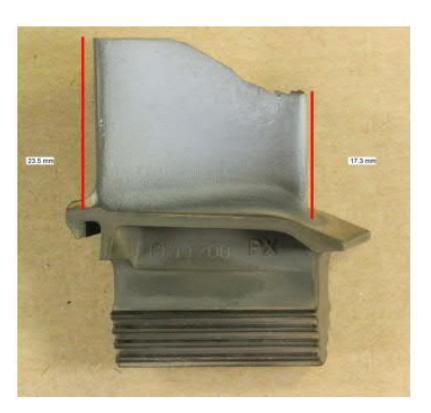
¹⁰³ **IP turbine blade failures, and risk for the fleet**

□ There have been 3 IPT blade failures all on GT dual fuel engines.

- □ There have been no primary G rated IPT blade failures. G and GT blades are identical except for material.
- One IPT blade failure occurred at 49K hours TSN in 2018 :

- □ Failure had originated at the trailing edge approx. 23mm above the platform. Heavy o with the coating SRZ indicated it had been initiated very early in the life of the engine. significant time. At the mid-section more rapid HCF occurred leading to blade release

- A secondary area of fatigue was present on the leading edge.
- Other blades in the set were found to have leading edge cracks
- Analysis did not find any metallurgical or dimensional defects to explain the failure. Having excluded other possibilities it was concluded the most likely cause was an unusual operational condition early in the engine life that initiated the cracking although no data is available to identify this.

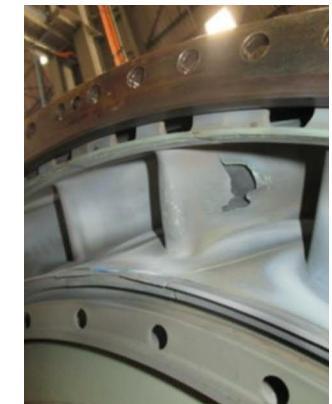
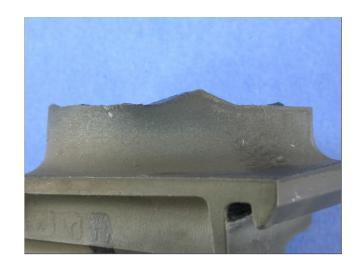
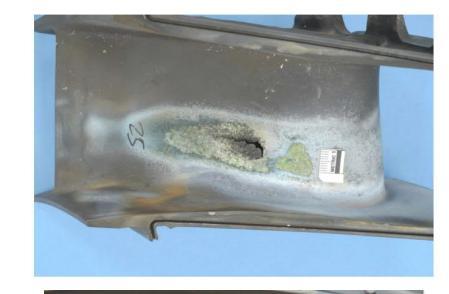
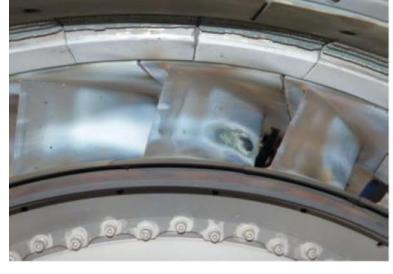
103 IP turbine blade failures, and risk for the fleet

- □ Two failures occurred at the same site on adjacent units both in early 2019. The engines had completed 88.7K and 76.6K TSN. Failure initiated at the TE ~5mm above the platform and propagated in HCF. No metallurgical defects were found.
- Investigation of these engines showed both to have suffered significant damage to the IPNGV's upstream of the IPT rotor due to high temperatures.
- The turbine damage was most likely caused by fuel quality issues although limited data was available to evaluate this.
- □ This resulted in excessive temperatures that resulted in loose blade shroud interlocks. This, as well the aerodynamic disturbance from the holed IPNGVs, resulted in vibration of the IPT blades causing failure.
- □ These failures are therefore considered to be due to operational issues and are not related to the 2018 failure.
