LM2500 engineering update ETN Conference Follow-Up to 2020 Meeting

March 4, 2021

2020 ETN LM2500 Conference | Follow-up | March 4, 2021

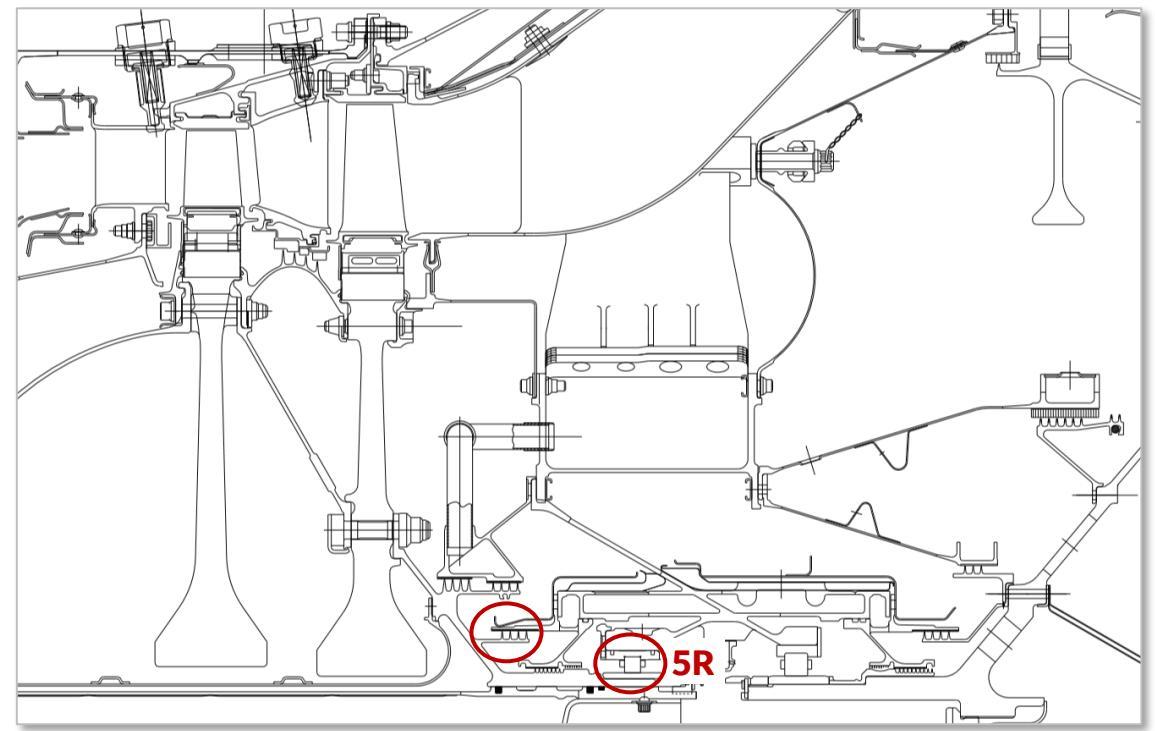
Location of 5R bearing

- GE removed the Al2O3 coating on the aft shaft inner labyrinth seal in 1998 due to concerns of hard particle entrainment into the C-sump .
- The IRM manuals for the Plus and +G4 engines included this change.
- The IRM update for the Base engine was missed and updated in May 2019.

• Since 2016, there have been more 5R bearings events in Base engines than for Plus and +G4 engines:

- The discrepancy between Base engine new-make vs. repaired parts confounds correlation with the seal condition.
- Fleet experience, including repetitive events on specific engines, points to Al2O3 from the coating as a possible contributing factor along with other potential sources.

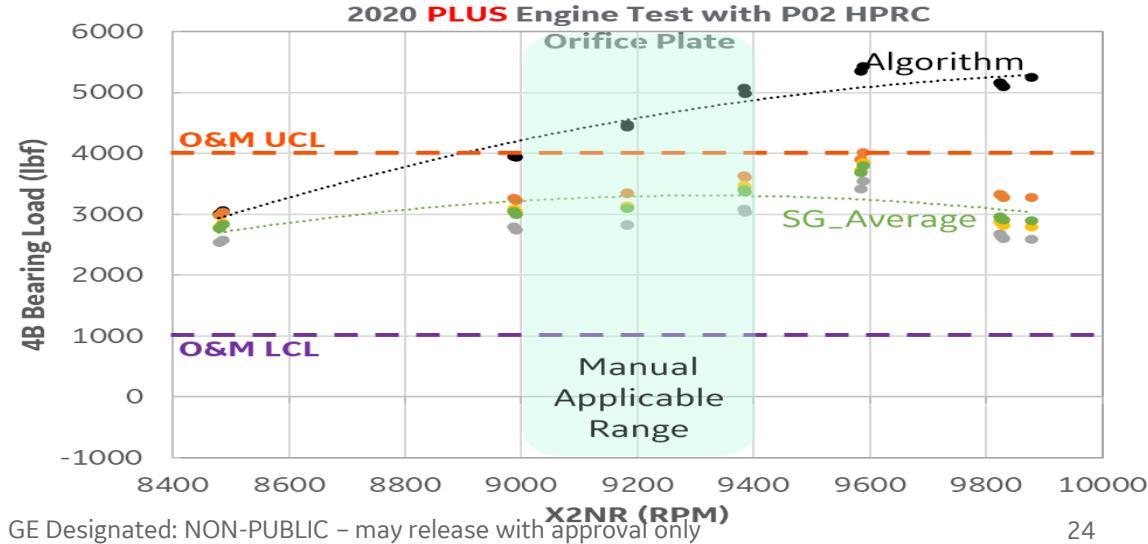
LM2500+ algorithm and measured thrust

- Rotor thrust algorithms have been investigated as part of recent 4B bearing events.
- GE has completed three instrumented engine tests since 2018. .
- The G4 algorithm shows very good agreement with instrumented test • data acquired at EIS (2007) and most recently in 2018.
- Compared to the algorithm, recent LM2500+ test data indicates a flatter load vs. speed relationship.
- There has been one confirmed 4B bearing skidding event in the • LM2500+ fleet; engine was operating at low load for extended time.

- There is good agreement between cavity pressures & measured thrust.
- LM2500+ design changes made since 1998 are being investigated to . better understand the data.
- The LM2500+ algorithm may be updated in 2021; no changes will be • made for the G4 algorithm.

- Continue to follow manual recommendations for HPRC orifice sizing.
- Contact Baker Hughes or GE Power for additional guidance as needed. .

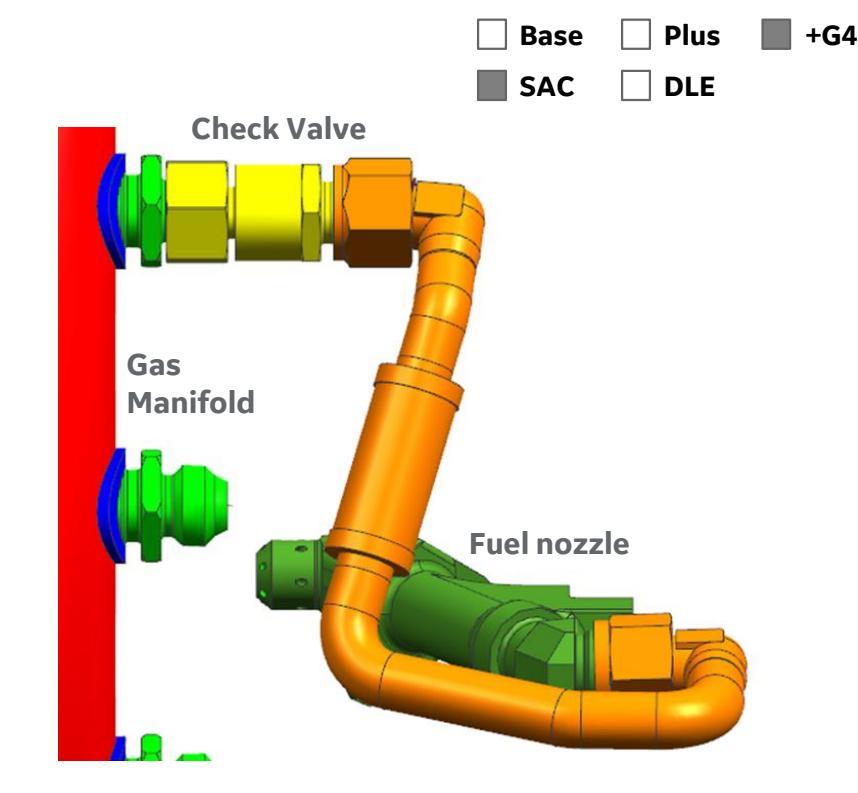
• Partially-burned hydrocarbons can contaminate the gas fuel circuit during liquid fuel operation, causing subsequent T48 spread issues during gas fuel operation.

- Back flow occurs due to nozzle-to-nozzle pressure variation and/or loose B-nut fittings.
- Fuel quality is an important variable.

Hydrocarbon deposits in the gas circuit

- Ensure fuel fittings/connections are properly tightened.
- Ensure liquid fuel meets specification.
- Consider using check valves to improve gas circuit cleanliness.
- Work with your packager to incorporate a forward purge system.

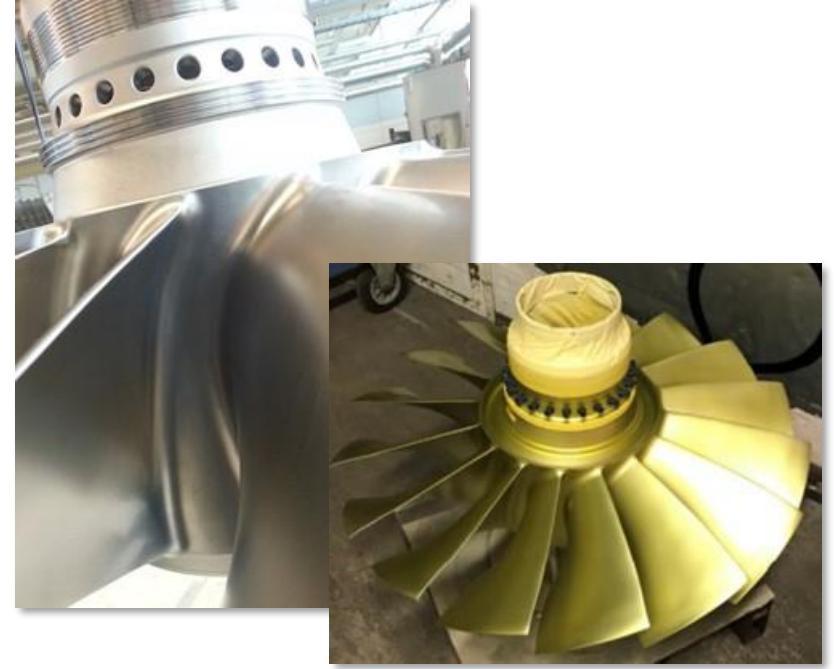
Post Repair with Sermetel Coating

• Blisks operating in saltwater environments can develop corrosion pitting on the airfoils and shaft interior.

- A blend repair procedure is being developed for flow path pitting.
- Different blend geometries will be used for various pitting locations.
- Reduction in cyclic life limit is expected post-repair.
- Target repair availability by end of 2020.

- Sermetel coating application available for all blisks exhibiting corrosion pitting.
- Evaluate expansion of repairable regions

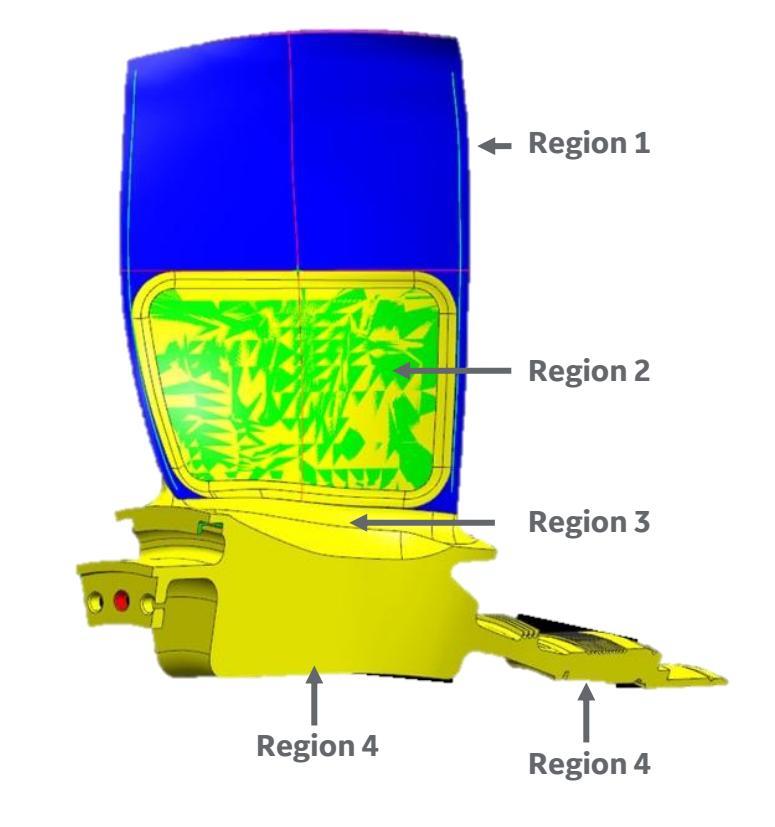
Areas where repairs are allowed / not allowed

- Region 1: Upper 50% of airfoil
 - This region generates and delivers the shock wave of the transonic airfoil tip.
 - Repair limited to local blending no deeper than 0.006 mils.
 - Repairs approved via departure record (Aviation repair engineering approval).
- Regions 2 and 3: Lower 50% span of airfoil, fillet radius, and platform
 - Generalized repair document in development to allow blend repairs to 0.020 mils in depth.
 - Includes L/E and T/E blend regions in already-issued Repair Document.
 - No departure record required.
- Region 4: Bore and Shaft ID
 - No blending allowed.

Blend Repair Document is planned to issue 2Q21

- Life assessments for blend-repaired blisks have been completed ... declared life to for repaired blisks has been reduced to 4,000 cycles since new.
- Blending will require P/N change and O&M manual updates.

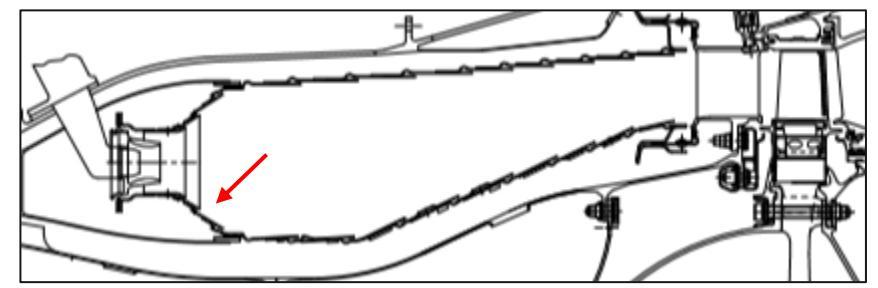
Combustor cross-section

• Some G4 SAC engines have experienced combustor dome plate cracking/oxidation.

- Early removals (~10k hours) have been attributed to poor fuel quality.
- Other removals have occurred after 25k hours of operation, but with more hardware distress relative to LM2500+ experience.

- An upgraded G92 combustor has been introduced to improve durability in NOx water applications.
- The improvement has been substantiated by analysis and field service evaluation.
- The G92 design is also expected to improve durability in dry applications.

- Ensure that gaseous and liquid fuels meet specification to prevent early distress.
- If needed, the G92 combustor is available beginning 1Q21.

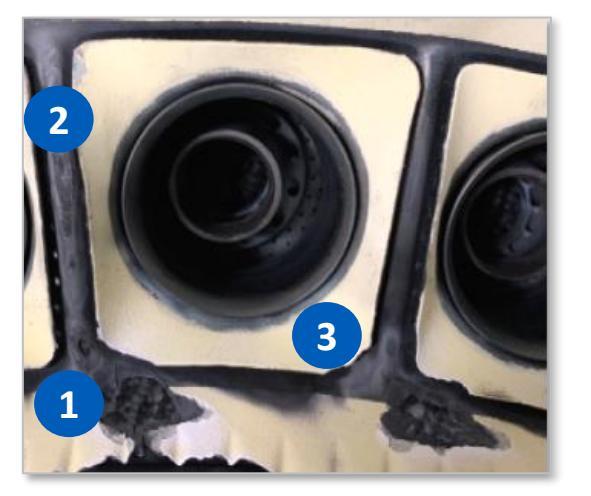
- 1. Oxidation at dome inner band location ... life limiting area
- 2. Oxidation at dome plate rib location between cups ... high-time issue
- 3. Missing material at splash plate corners

- Updated versions of SAC combustors are being introduced for both wet and dry operation
- Enhancements include additional dome and splash plate cooling and improved splash plate gap control
- A field service evaluation is ongoing at an LNG site with positive results

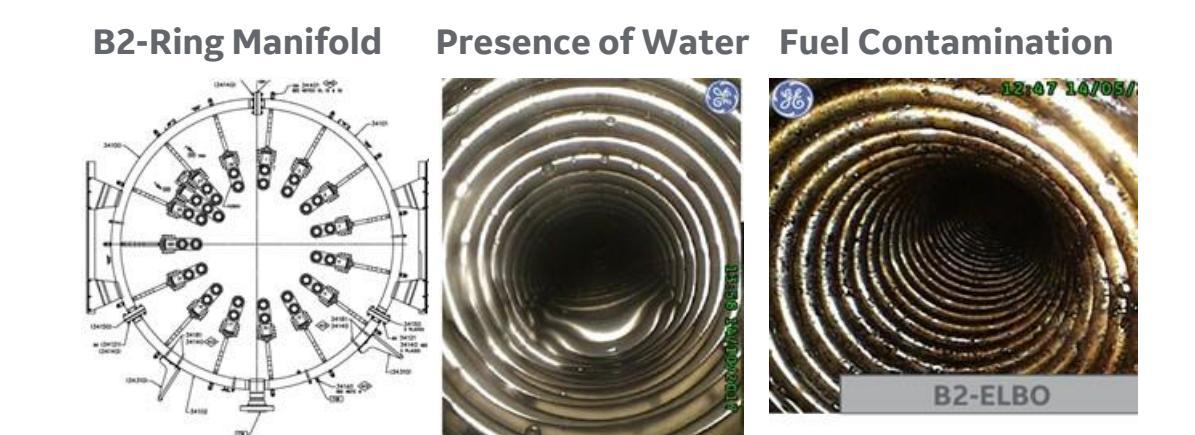
- A B2 gas hose rupture noted after transition to gas operation after extended liquid operation.
- Gas hose rupture led to gaseous fuel leakage in package.

- 1. During liquid operation, water can accumulate in gas manifolds in moist environments.
 - During switch to gas fuel, rapid evaporation of water can over-pressurize gas hose.
 - Source of water is combustion air that circulates in the gas fuel system due to premixer cross-talk.
- 2. Heavy hydrocarbon condensation in gas hose and subsequent autoignition with combustor air.

Ruptured hoses

- Check valves prevent premixer-to-premixer cross-talk and eliminate the water source.
- Check valves via SB301 in April 2019.
