TRANSCANADA TURBINES

Corporate Presentation

**INDUSTRIAL RB211
USER GROUP**

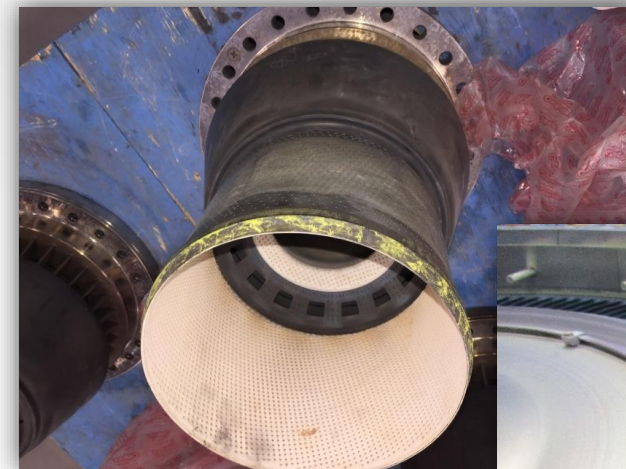
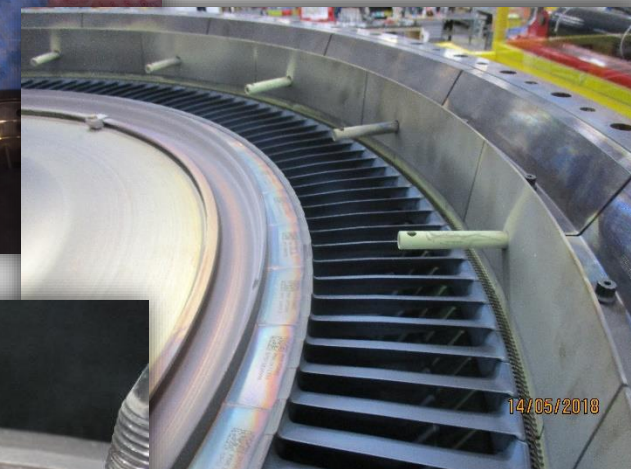
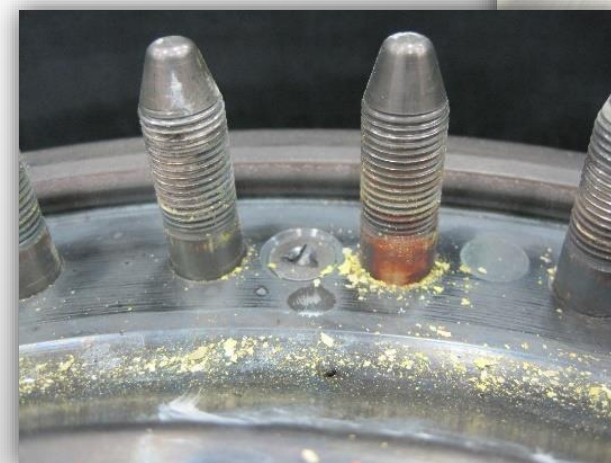
Siemens: A residue, yellowish in colour, has been found on some components in the hot sections of some Siemens gas turbines, that include but not limited to the gas flow path and exhaust casing insulation. In some cases, tests have found hexavalent chromium (Cr(VI)) in this residue. Cr(VI) is a highly regulated substance, and has been identified as a human carcinogen by recognized governmental and health authorities

- Conduct a Hazard Assessment + Develop SWP
- Site activities involving removal and contact with DLE DCN/Comb/Supports, T455's, BOV's are most likely to result in possible exposure.
- Provide training and awareness to maintenance personnel
- Use PPE and follow your SWP
- Establish safe practice to clean-up/remove deposits and prevent any deposit becoming airborne.
- Dispose of contaminated waste IAW local regulations.

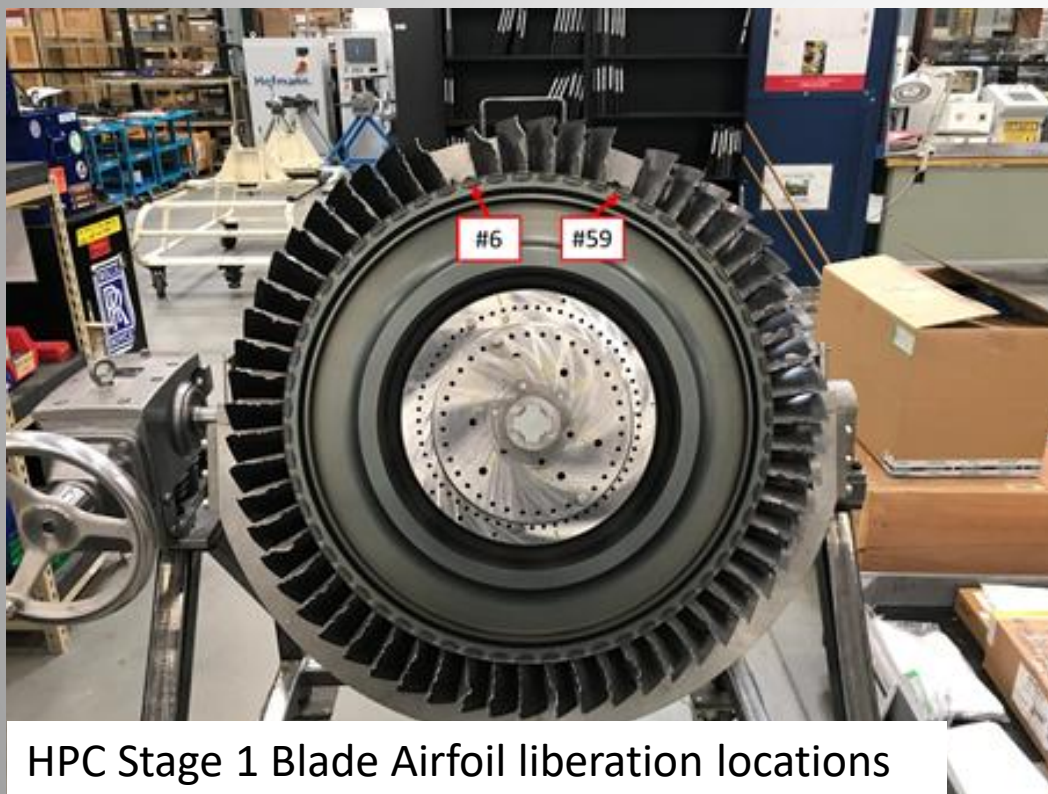
HPC Stage 1 Blade Airfoil liberation locations

- Extensive damage to HPC Blades and Vanes with nicks, dents and tears present in all stages
- HPC Stage 1 Blades: QTY.2 blade airfoils liberated
- HP OGV: ledge edge nicks and dents
- Material splatter and minor impact damages observed on the HPT Blades and HPNGV's.

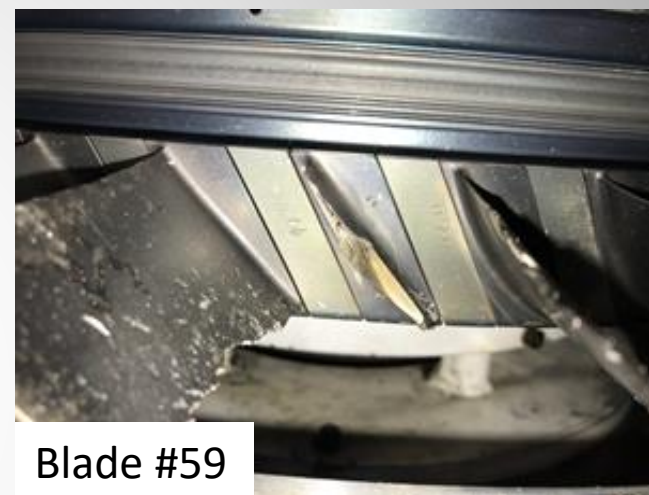
Blade #59

- Zone 1: Leading edge deformation moving from the concave surface to the convex. Leading edge tear condition has visible oxidation present
- Zone 2: Thumbnail shaped, flat and visibly oxidized fracture surface. Characteristics are consistent with stable fatigue crack growth.
- Zone 3: Fracture surface consistent with overload condition.

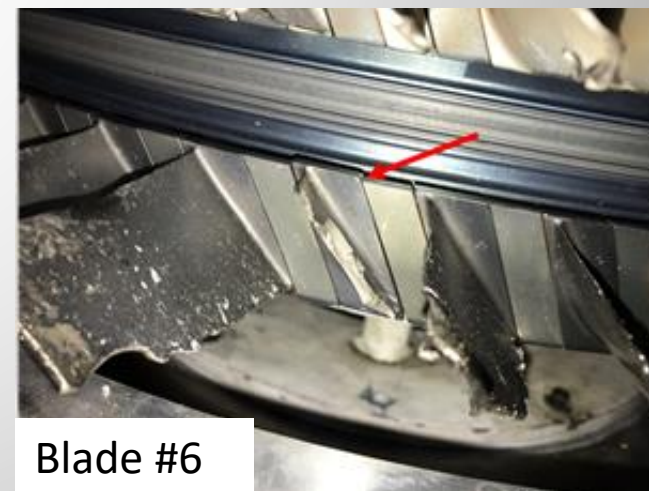
Blade #6

- Fracture surface is consistent with an overload failure condition
- Probable that this blade sustained an impact from an object

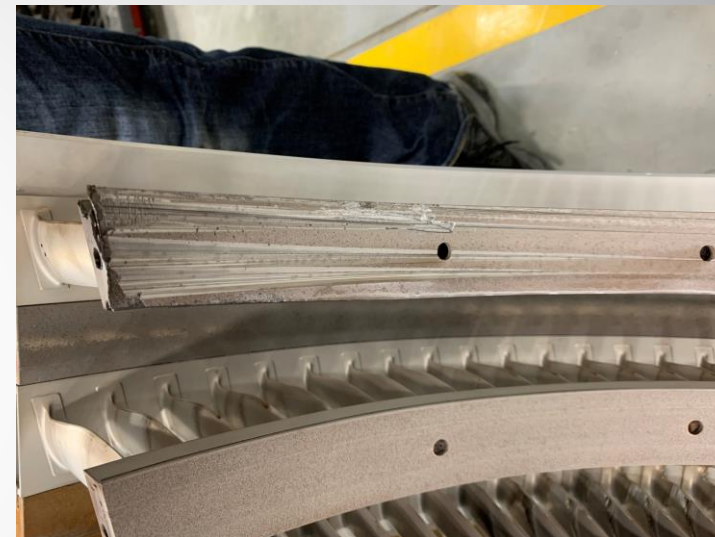
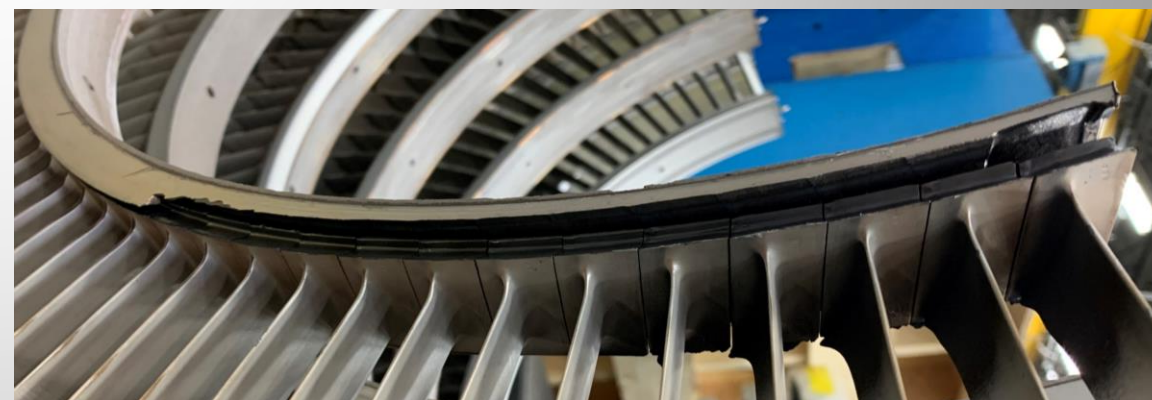
Preliminary Findings - IPC Stage 6 Shroud/Vane Assembly

- Upper shroud segment: 350mm of shroud lost location allowing for forward movement.
- Loose shroud condition resulting in:
 - multiple non-parallel, non-overlapping knife seal cut paths in the abradable lining
 - Rubbing with the aft face of the IPC stage 6 disc rim
- Foam injection still present although highly degraded and burnt
- Heavy fretting, material loss and bluing present in both the shroud and end vane

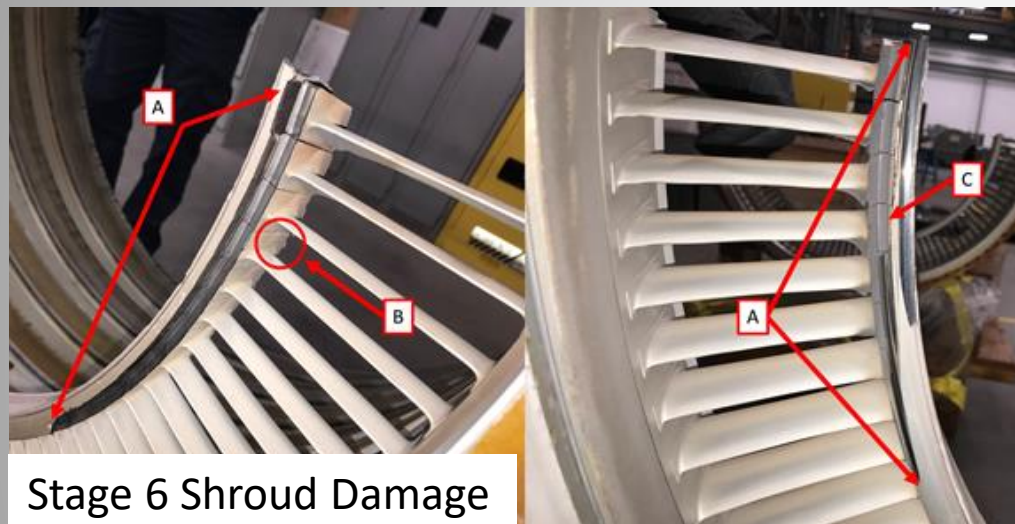
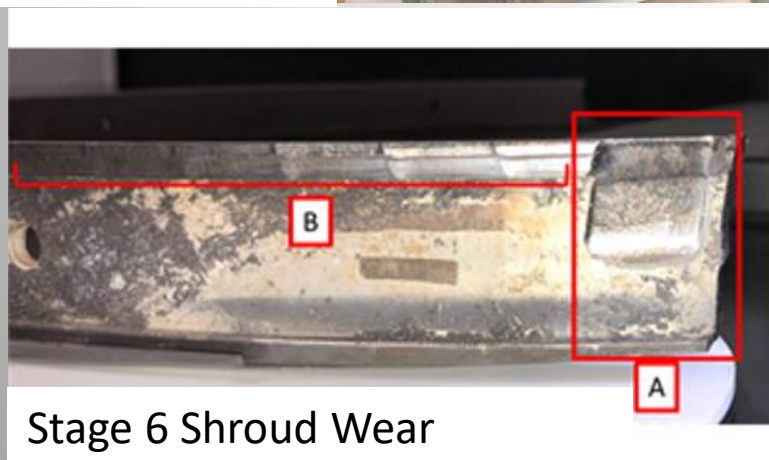
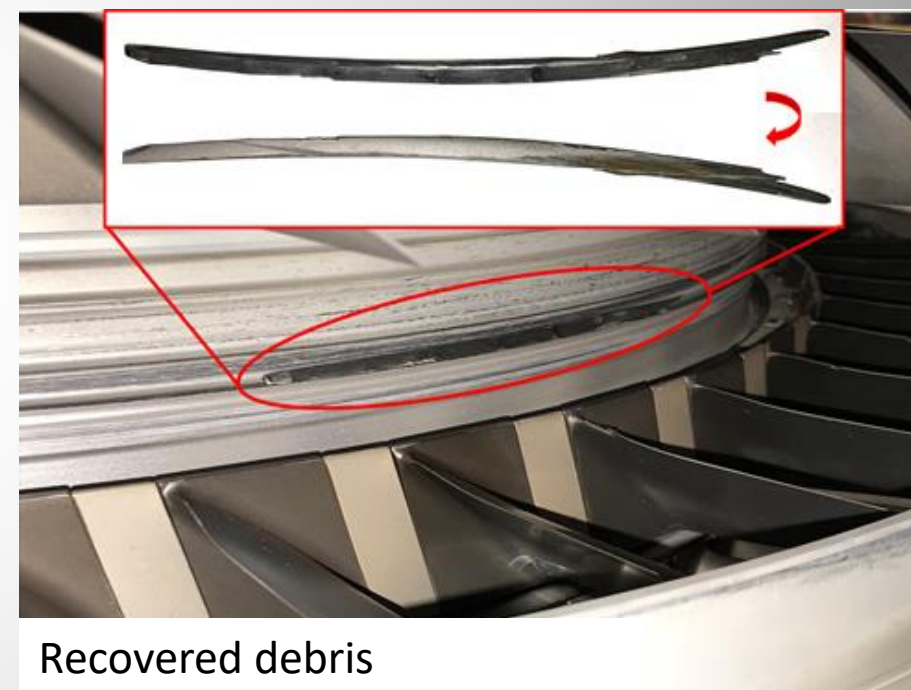
Depot Observations – IPC Stage 6 Shroud/Vane Assembly

- IPC Stage 6 disc and blades were found to have heavy rub condition as evidence of bluing and wear marks.

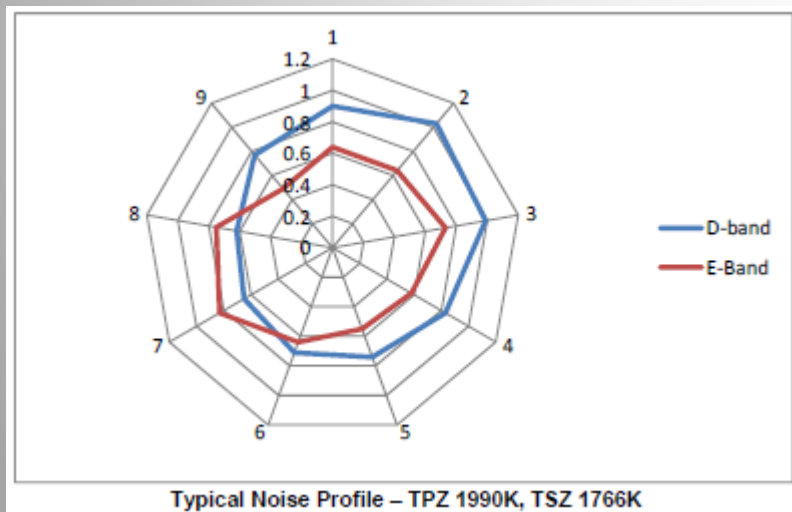
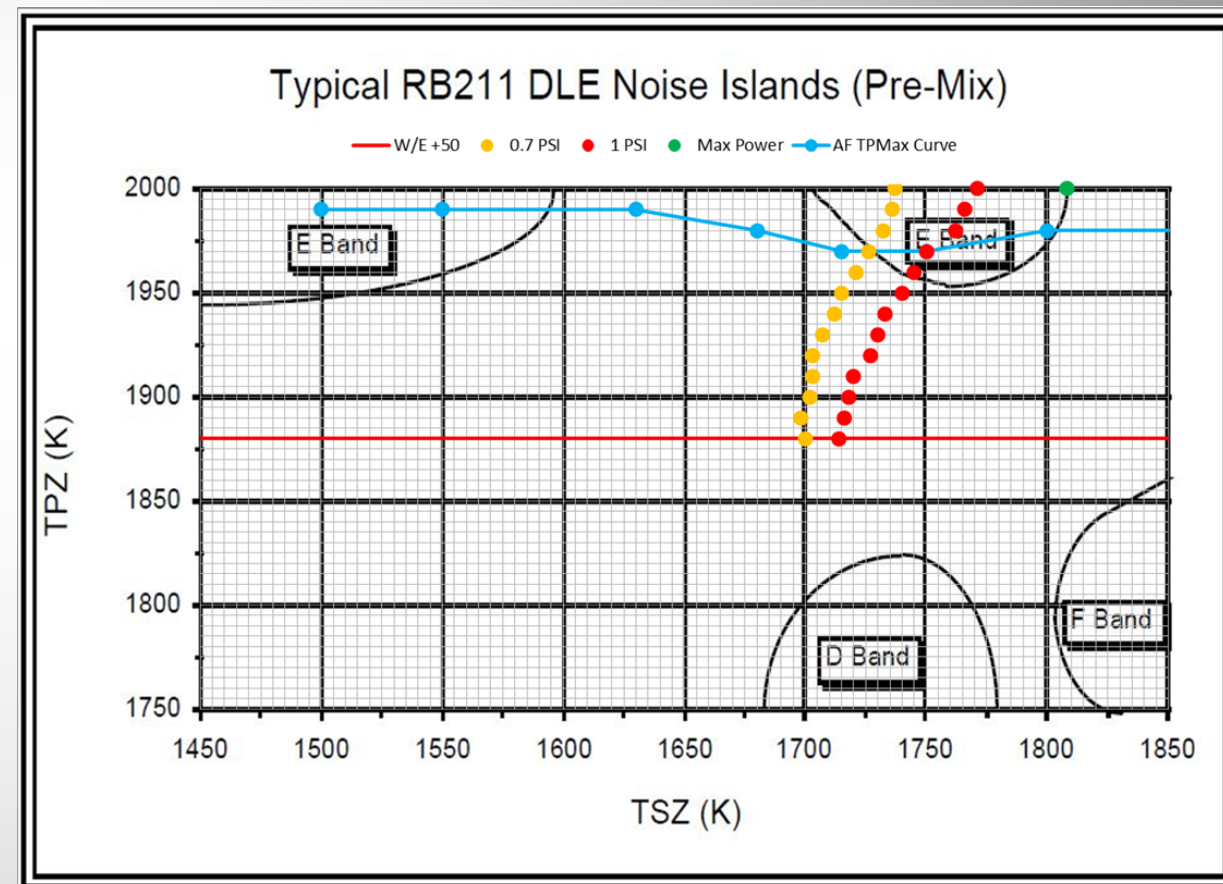
- The noise kit allowed a pot to pot profile to be determined
- D-Band was found to be common to all combustors
- Wall of D-Band present at 1700K TSZ.
- No “way around” the D-Band noise.

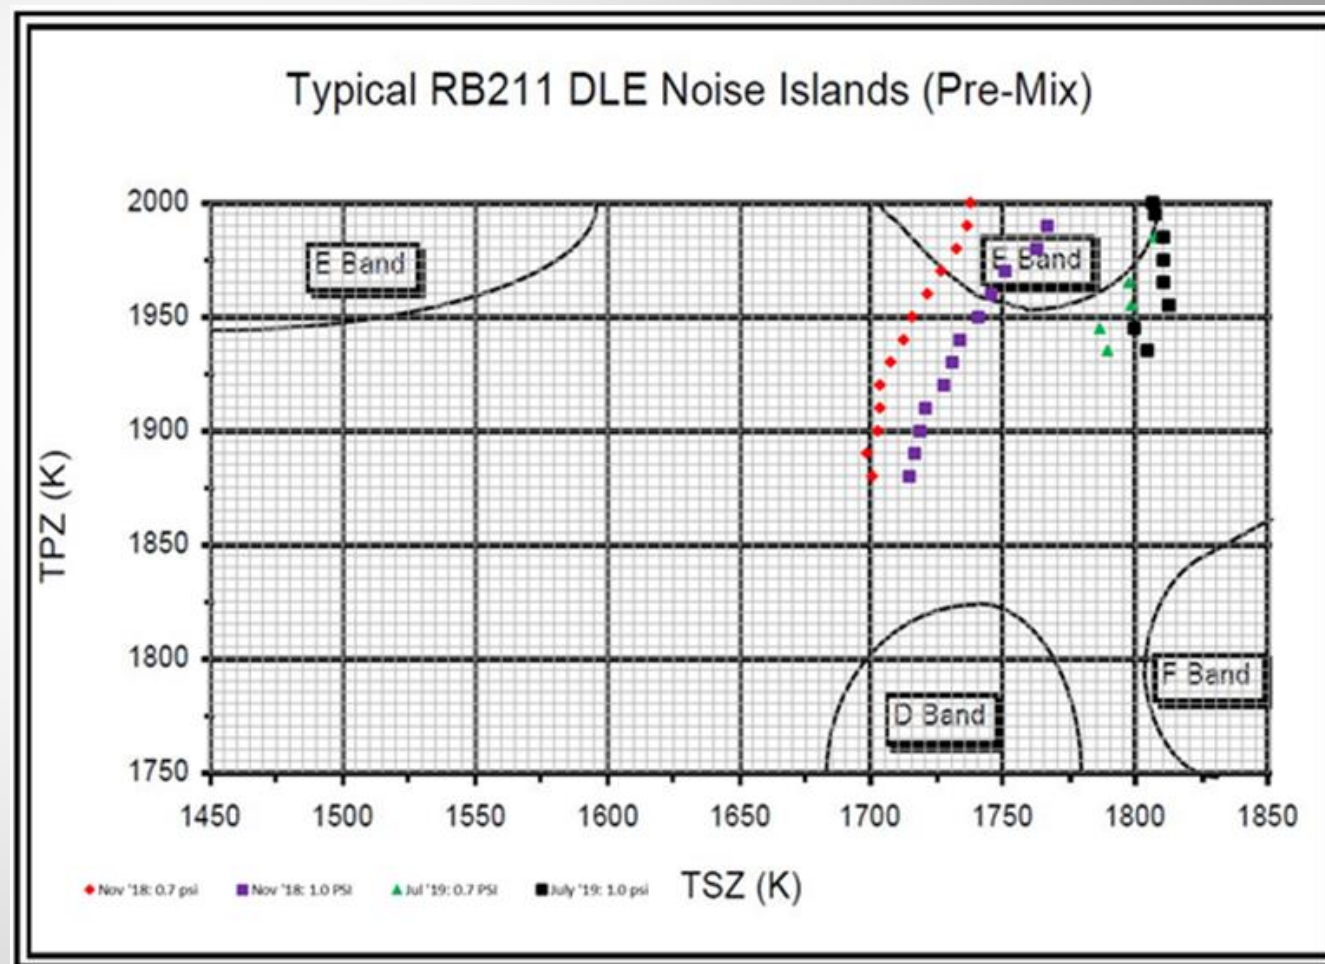
- The effect of the discharge nozzle replacement can be seen here.
- Significant shift up the TSZ scale of the D-Band noise. 0.7 psi isobar now at approx. 1800 K compared to 1700K pre-discharge nozzle overhaul.
- Noise control activation point is 0.8 psi.

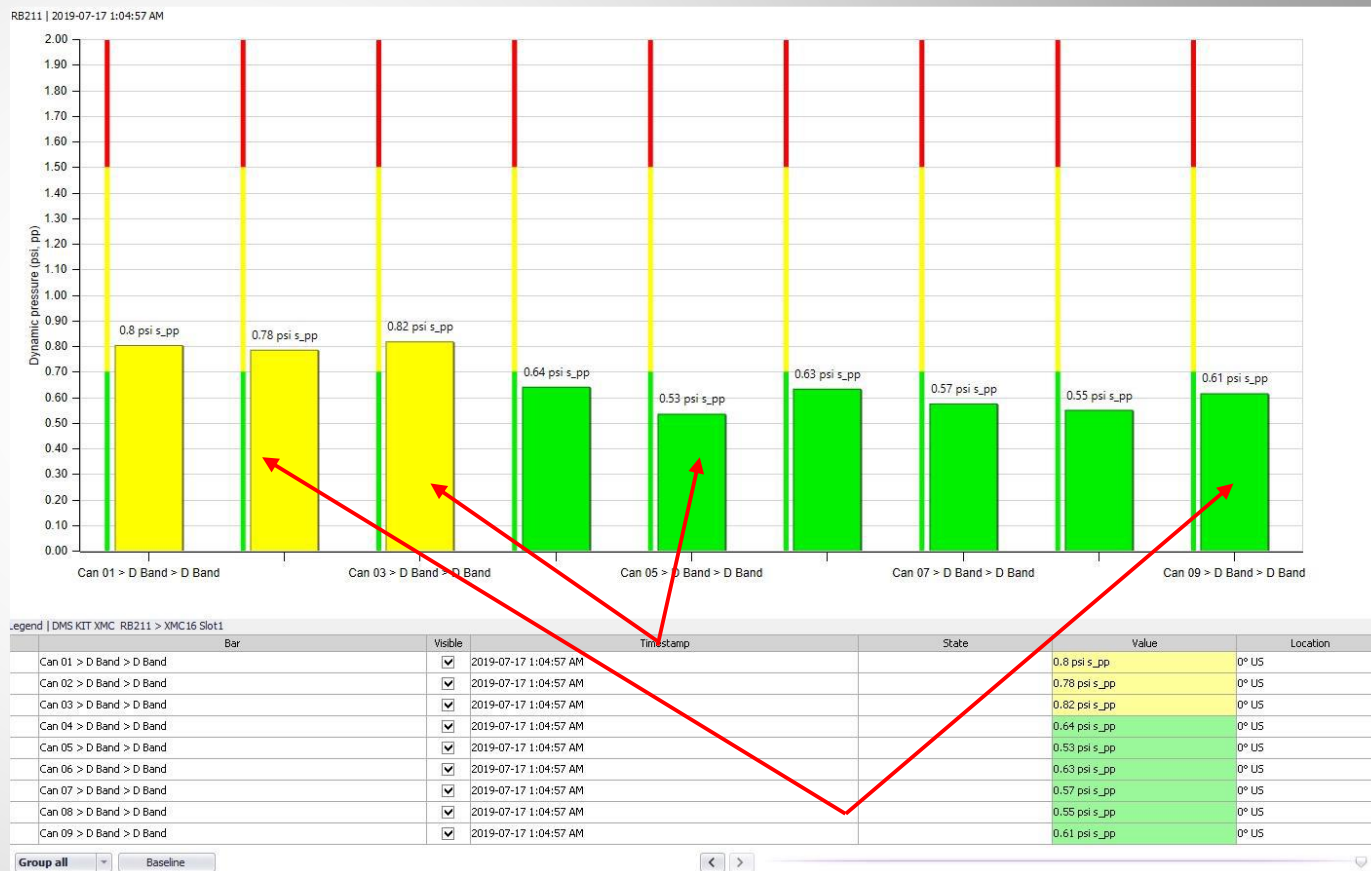
- Kit allowed for further optimisation with individual combustor swaps, in an attempt to even out the noise profile.

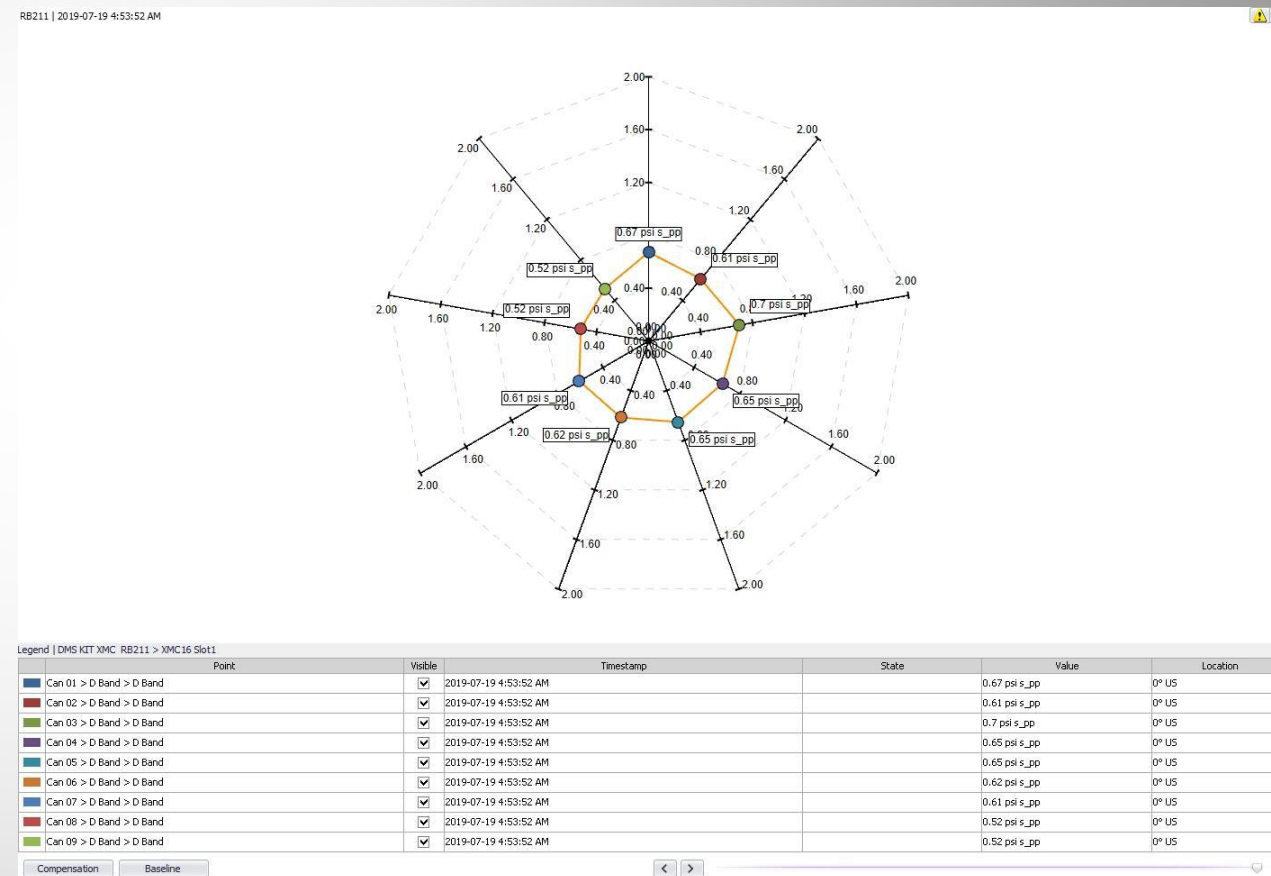
- More even D-Band noise profile.
- Within site limits for noise control.
- No TPZ Offset.
- NOx emissions fully optimized within site limits.
- TCT has carried this work out x3 times in 2019/20.
- Each time, overhauling the discharge nozzles had a positive effect on D-Band noise profile.
- This work couldn't be done in the field without the kit.
- Mitigating the need for full overhaul earlier in the engine life.
- No engine removal required. Exchange options available also

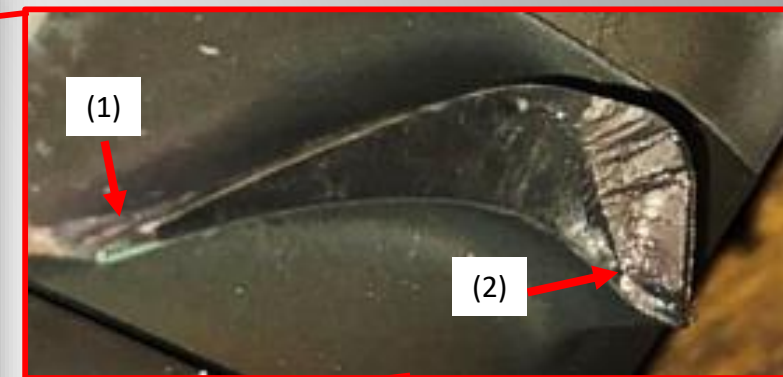
Incident IP Turbine Blade

1. Suspected Trailing Edge Fatigue
2. Suspected Leading Edge Overload

- TCT's investigation completed in the weeks after the 2019 ETN RB211 Conference
- Summary of Blade Analysis Findings:
 - IPT Blade fractured approx. 0.2" above the root platform
 - Crack origin at the Trailing Edge of the suction side
 - Metallurgical evaluation concluded the failure was crack propagation in high cycle fatigue (HCF)
 - There was no evidence of inherent material defect at the fracture origin
 - There was no evidence of a distinct FOD or DOD event as an initiator to cracking/fatigue
 - There was no evidence of environmental contamination on the incident blade

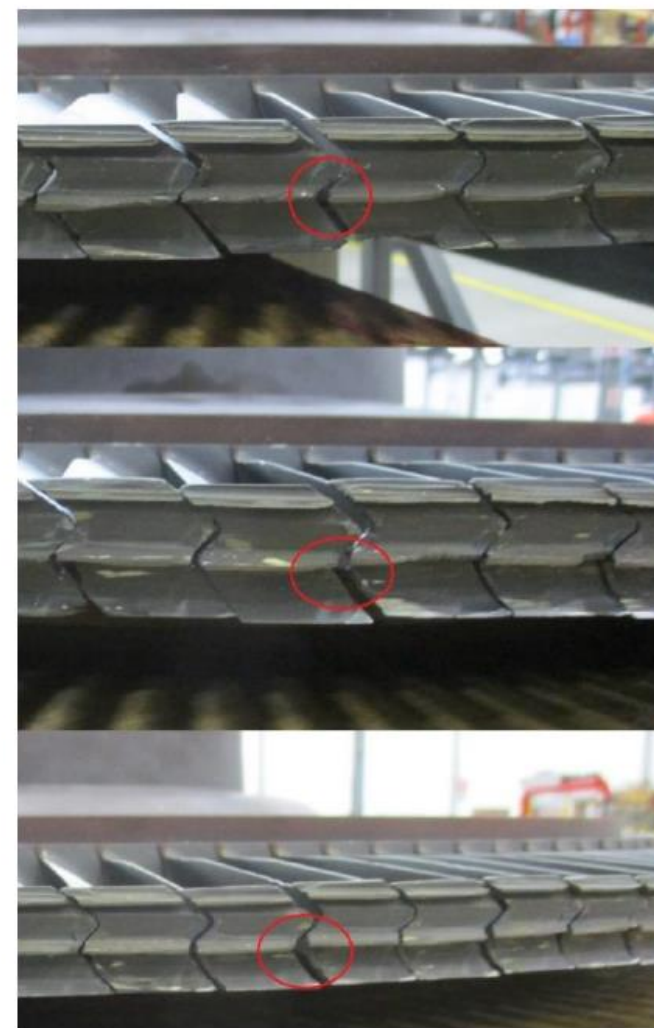
Abnormal IP Turbine
Blade / Disc Condition

Blade looseness/resonance

- Blade Creep Untwist
- IPT Disc firtree galling

- In theory, excessive shroud looseness could cause excitation and result in HCF
- Under normal operating conditions, blade creep can result in untwist of the blades. Creep untwist beyond design expectations could result in loss of shroud interlock and subsequent looseness/excitation
- Lab analysis discovered a degree of lean/untwist that was higher than previous GT IPT Blades (limited GT fleet sample size)

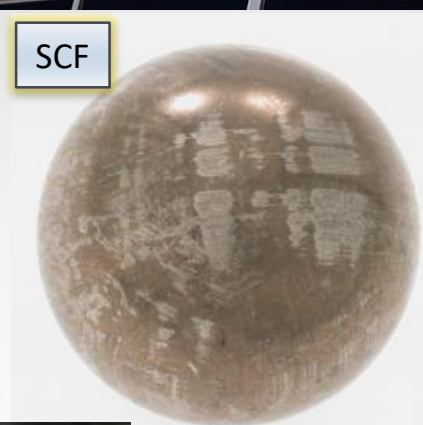
RCF

1. Rolling element/raceway rolling contact fatigue (RCF).
2. Progression to macro spalling (**flakes/debris on MCD's**).
3. Cage pocket wear & fatigue damage to cage.
4. Cage/riev failure leading to seizure, destruction of bearing, loss of rotor location.

- Monitor oil quality (particulates, acidity water content etc).
- Check MCD's at regular intervals.
- Monitor vibration and oil system parameters for trends and step changes.
- Ensure package air filtration is effective.
- Ensure package oil system is properly flushed before engine is returned to service (if previous bearing failure experienced).
