LM2500 engineering update ETN Conference Follow-Up to 2020 Meeting

March 4, 2021

2020 ETN LM2500 Conference | Follow-up | March 4, 2021

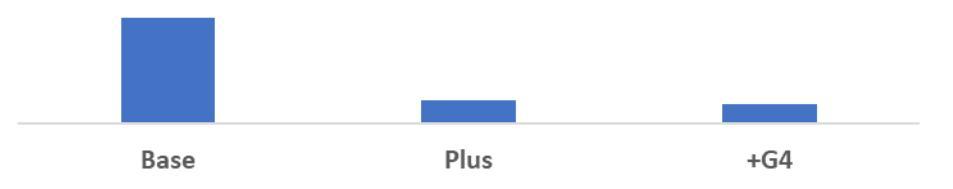
• Since 2016, there have been more 5R bearings events in Base engines than for Plus and +G4 engines:

- The discrepancy between Base engine new-make vs. repaired parts confounds correlation with the seal condition.
- Fleet experience, including repetitive events on specific engines, points to Al2O3 from the coating as a possible contributing factor along with other potential sources.

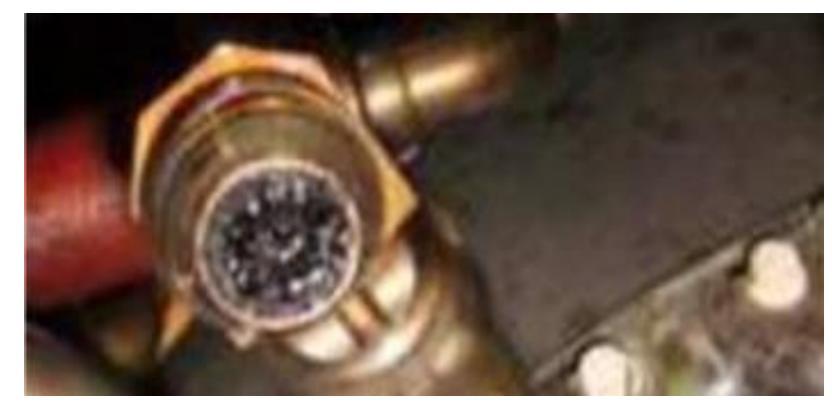
Hydrocarbon deposits in the gas circuit

• Partially-burned hydrocarbons can contaminate the gas fuel circuit during liquid fuel operation, causing subsequent T48 spread issues during gas fuel operation.

- Back flow occurs due to nozzle-to-nozzle pressure variation and/or loose B-nut fittings.
- Fuel quality is an important variable.

- Ensure fuel fittings/connections are properly tightened.
- Ensure liquid fuel meets specification.
- Consider using check valves to improve gas circuit cleanliness.
- Work with your packager to incorporate a forward purge system.

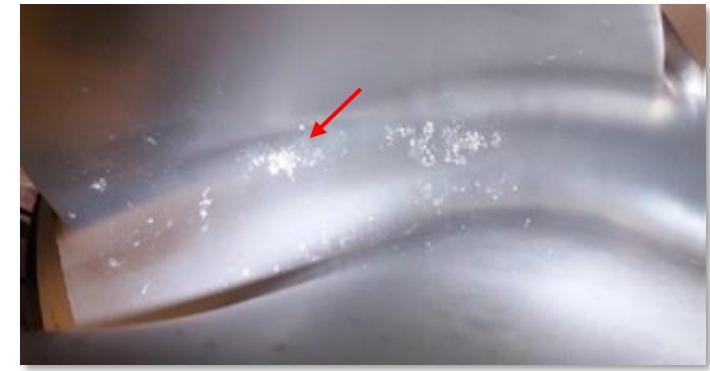
• Blisks operating in saltwater environments can develop corrosion pitting on the airfoils and shaft interior.

- A blend repair procedure is being developed for flow path pitting.
- Different blend geometries will be used for various pitting locations.
- Reduction in cyclic life limit is expected post-repair.
- Target repair availability by end of 2020.

- Sermetel coating application available for all blisks exhibiting corrosion pitting.
- Evaluate expansion of repairable regions

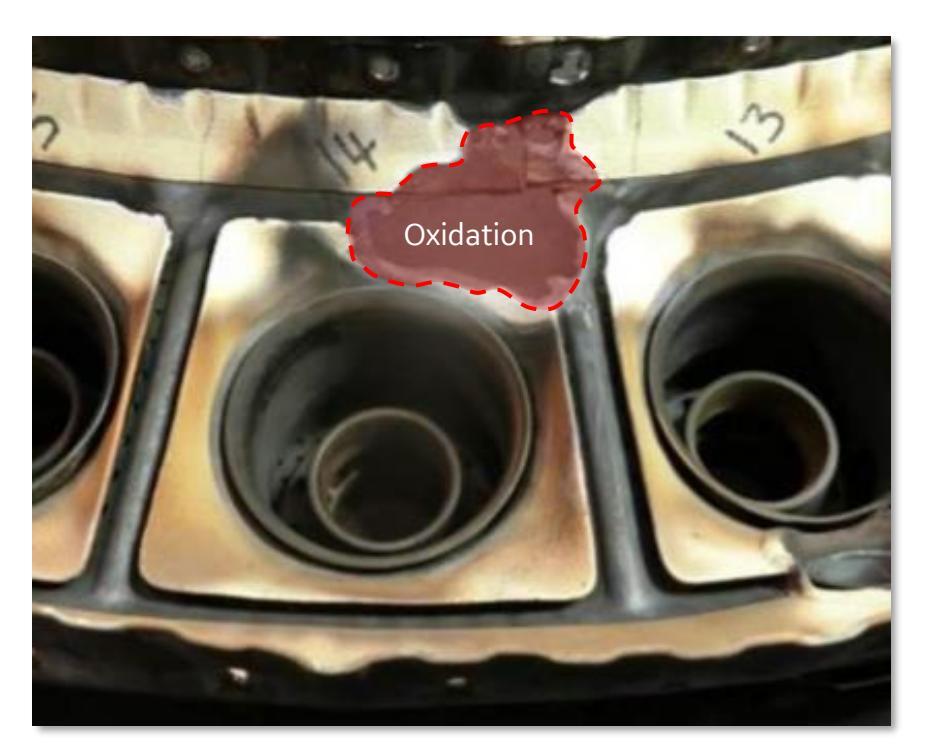
Combustor cross-section

• Some G4 SAC engines have experienced combustor dome plate cracking/oxidation.

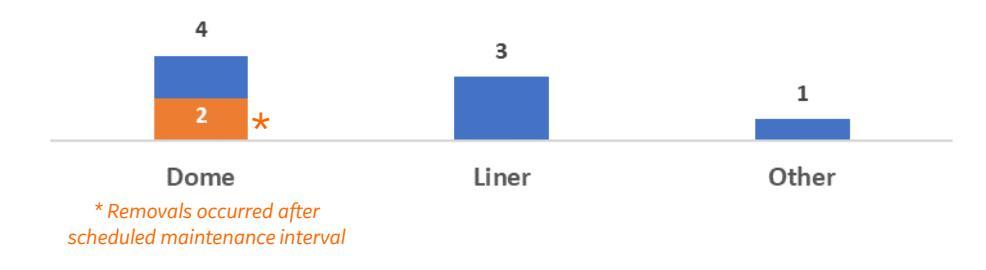
- There are approximately 1,100 LM2500 SAC-dry engines in service; maintenance interval dependent on fuel type
- Since 2013, there have been relatively few unplanned engine removals:

- 1. Oxidation at dome inner band location ... life limiting area
- 2. Oxidation at dome plate rib location between cups ... high-time issue
- 3. Missing material at splash plate corners

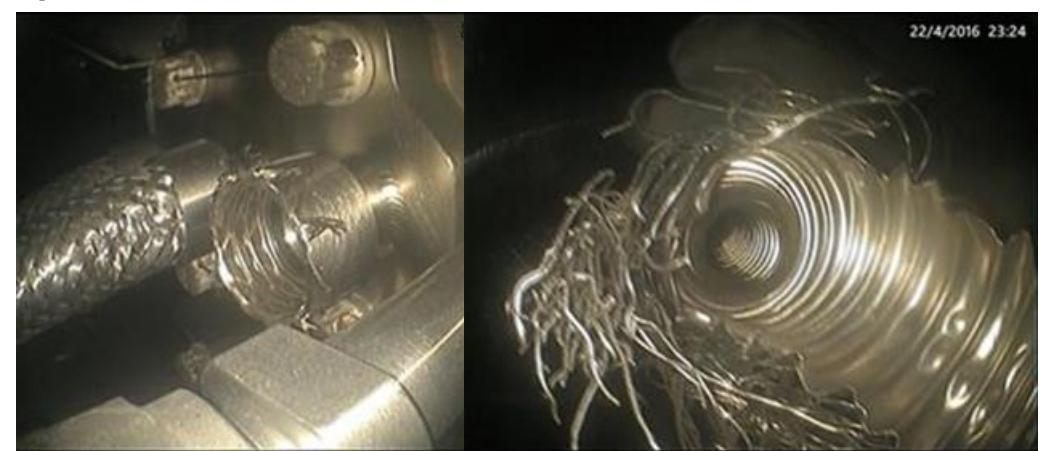
Ruptured hoses

- A B2 gas hose rupture noted after transition to gas operation after extended liquid operation.
- Gas hose rupture led to gaseous fuel leakage in package.

- 1. During liquid operation, water can accumulate in gas manifolds in moist environments.
 - During switch to gas fuel, rapid evaporation of water can over-pressurize gas hose.
 - Source of water is combustion air that circulates in the gas fuel system due to premixer cross-talk.
- 2. Heavy hydrocarbon condensation in gas hose and subsequent autoignition with combustor air.
